Precision Inspection

Property Inspection Report

302 Wallis, Rollingwood, TX 78746
Inspection prepared for: Davis & Olivia Baker
Date of Inspection: 7/18/2023 Time: 9:00 AM
Age of Home: 1988 Size: 2950
Weather: Sunny, 100 Degrees
Order ID: 1562

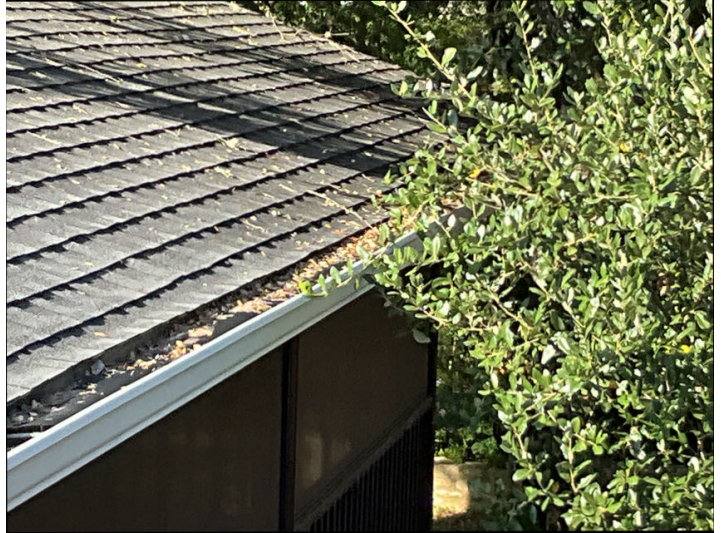
The gutter and downspout system was observed to be connected to underground drainage piping. Inspector cannot visually inspect the integrity of the underground drain system or proper drainage technique used.

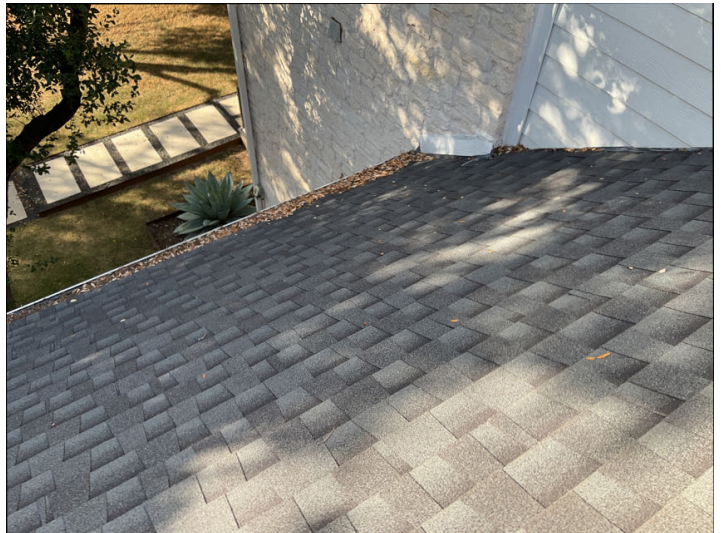
Gutter guards are sagging and are missing in one or more locations.

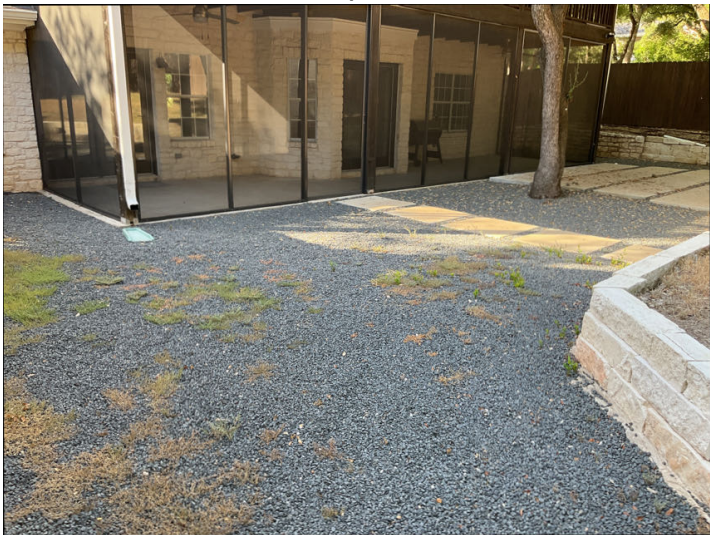
The gutter downspout is missing on the right side of the garage. Recommend installing splash block.

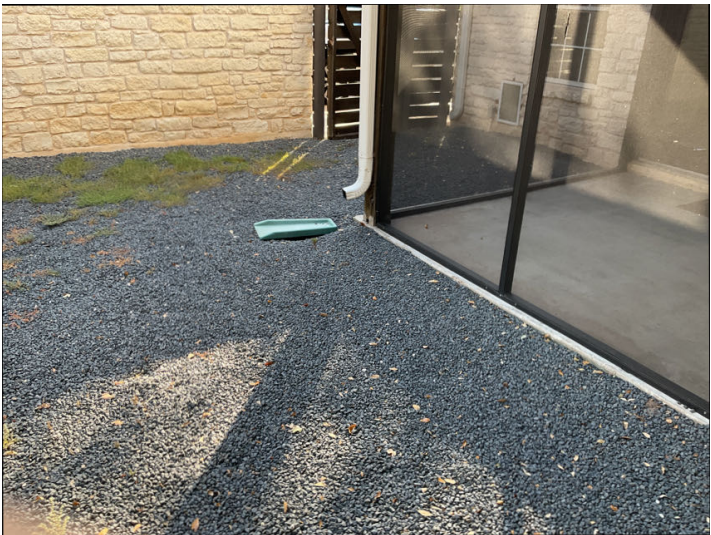
Negative grade or (poor soil grade) was observed, ground surface slopes towards the foundation or has less than 2% grade away from foundation. To keep surface water from collecting up against and or near the foundation grading should have a 2% slope (6 inches within the first 10 feet) away from the structure.

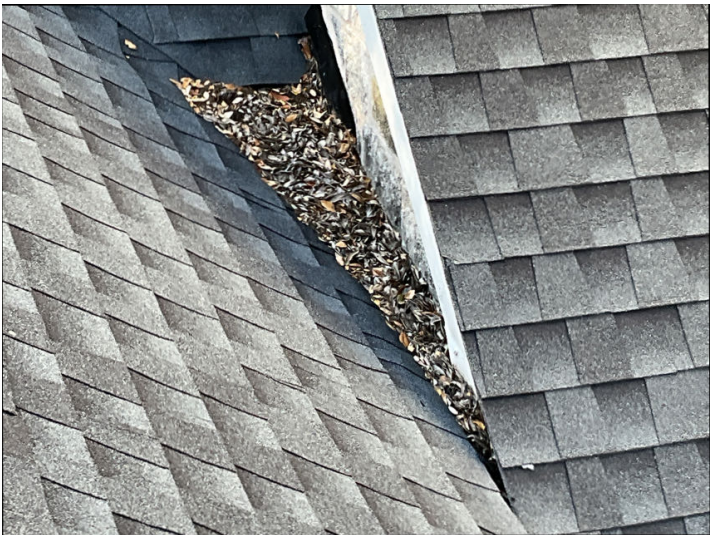
Debris on the roof surface observed in one or more locations.

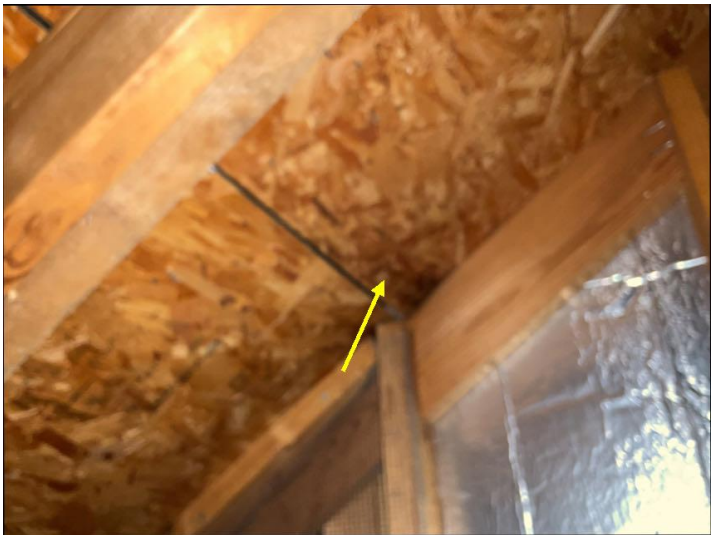
Water stains observed on roof decking in one or more locations.

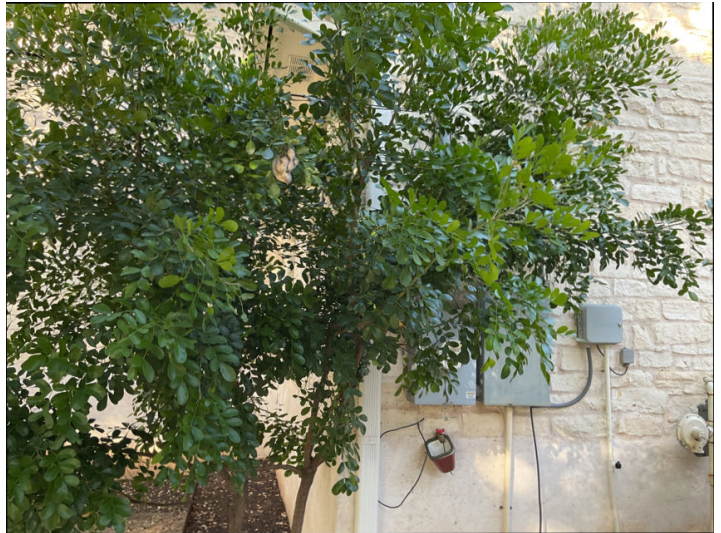
Lack of weep holes installed in Exterior rock veneer at the rock perimeter footing ledge. Common to see an older homes.

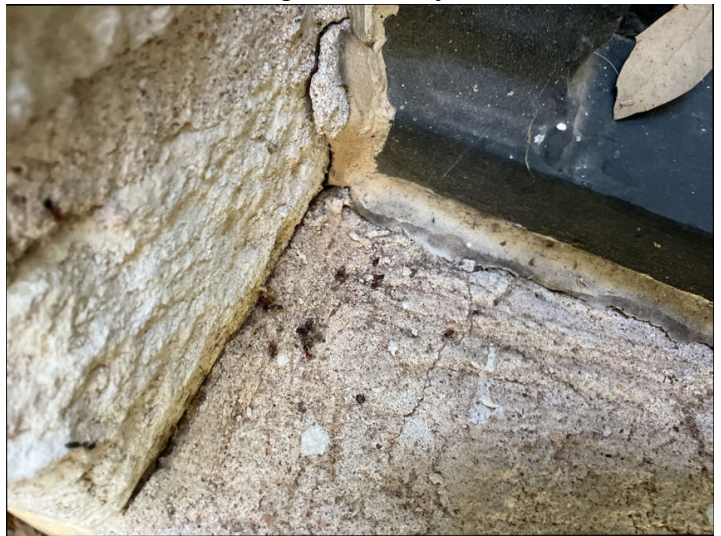
Lack of weep holes in rock mortar above windows. Common to see you on older homes.

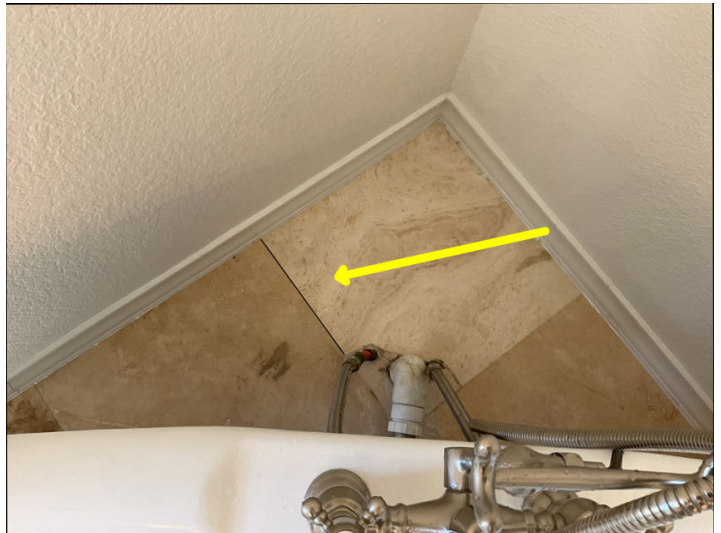
upstairs hall bathroom ceramic floor tile grout is missing and are cracked. Flores lifted in this area.

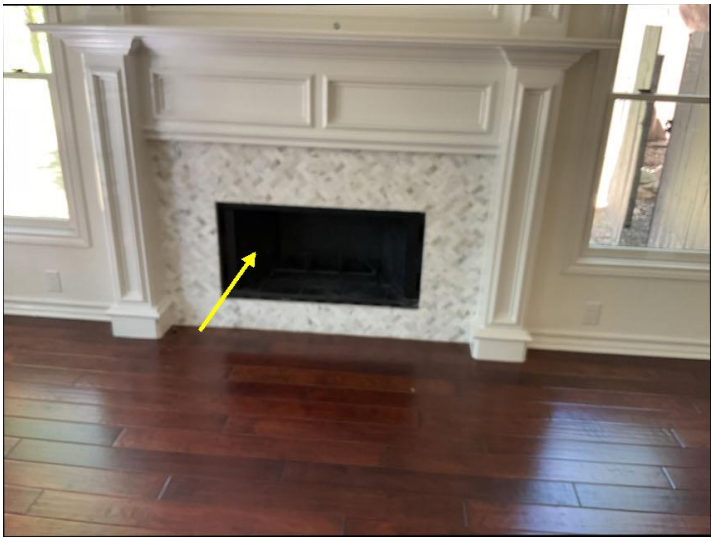
The front left formal living room fireplace opening is not equipped for the screen.

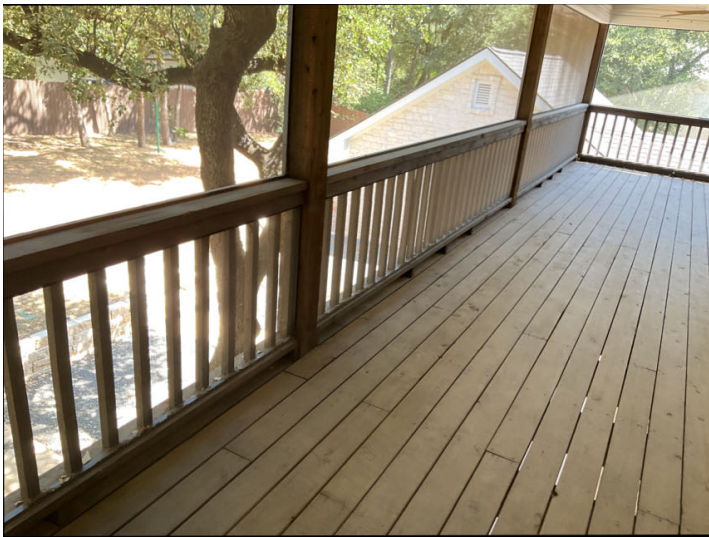
The upstairs back balcony railing balusters are more than 4 inches apart. Known child safety hazard.
Screen mash installed in front of the baluster openings

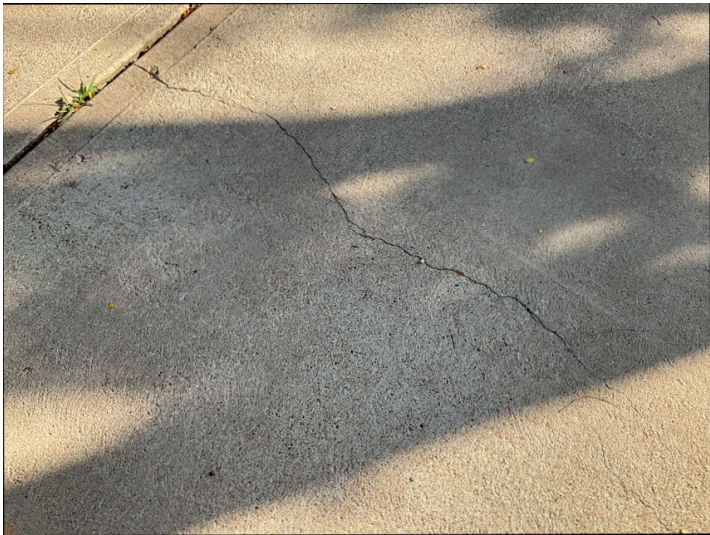
Cracks in driveway concrete surfaces in one or more locations.

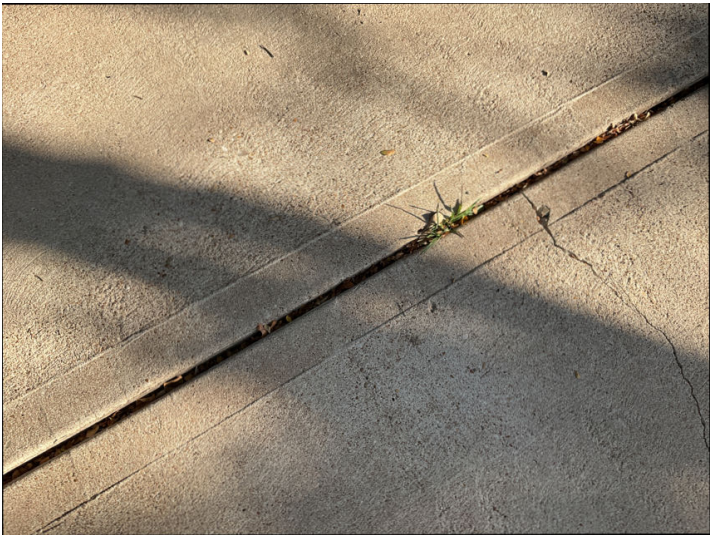
Driveway concrete expansion joint wood material is missing and or separated in one or more locations.

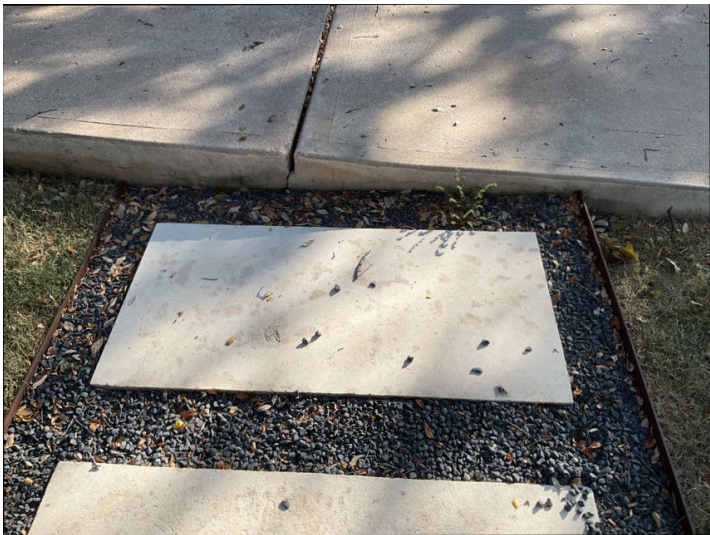
Front sidewalk concrete surface is below driveway surface Potential trip hazard.

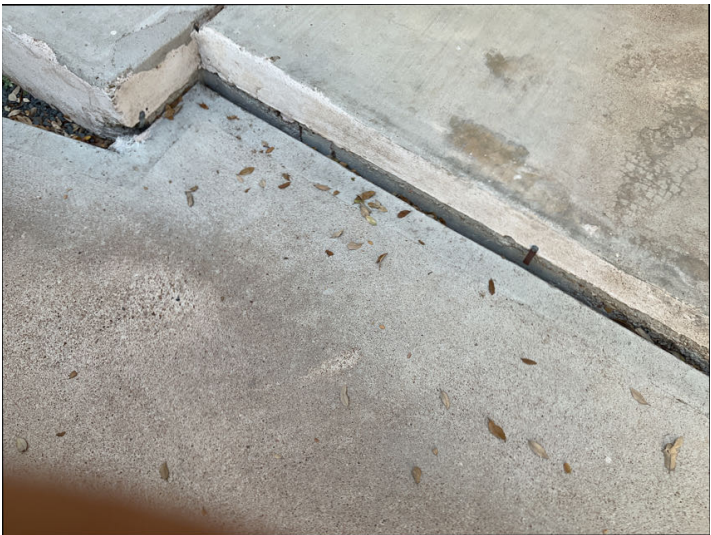
The driveway and settled at the back porch step area

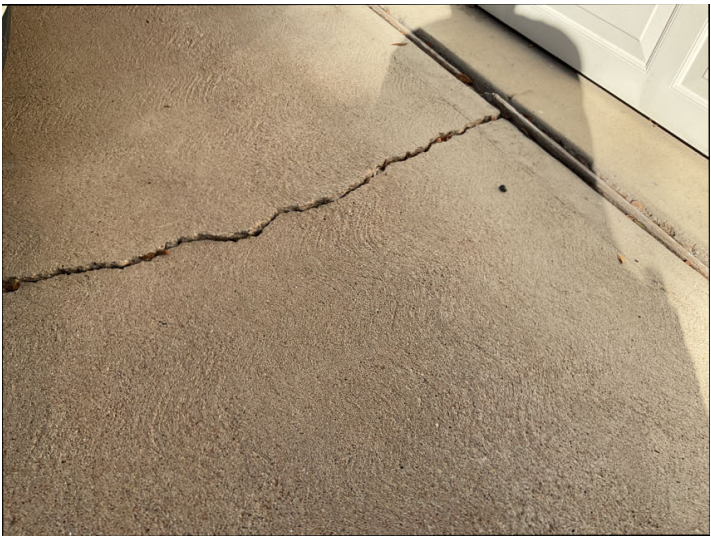
Cracks in driveway concrete surfaces in one or more locations.

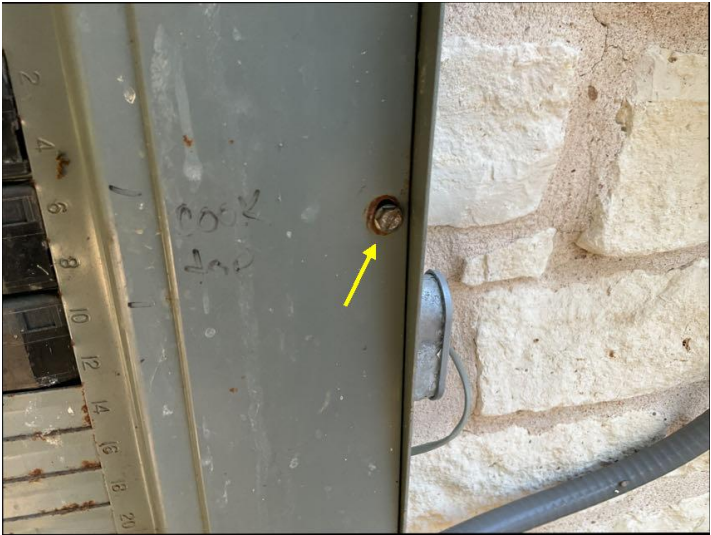
The main electrical panel box is not equipped with a main disconnect. Should have a main disconnect when six or more breakers are present.

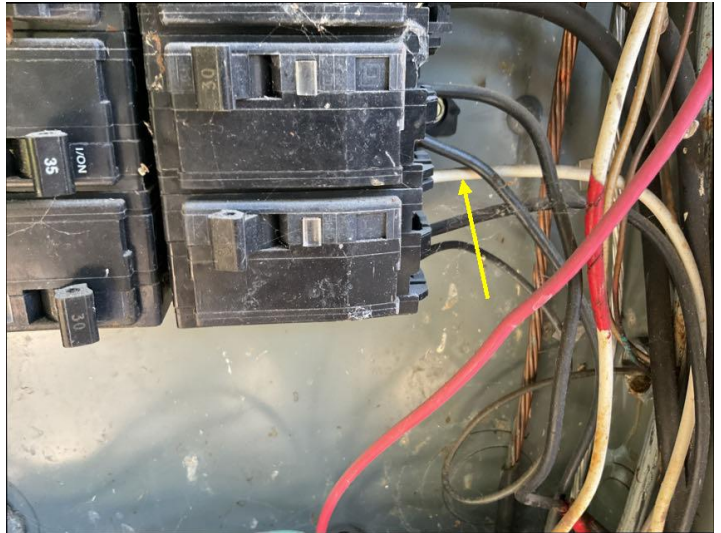
A 30 amp and 50 amp Breakers are double lugged. Two wires connected to the breaker. Both have one wire that's undersized for the breaker size. Fire safety hazard.

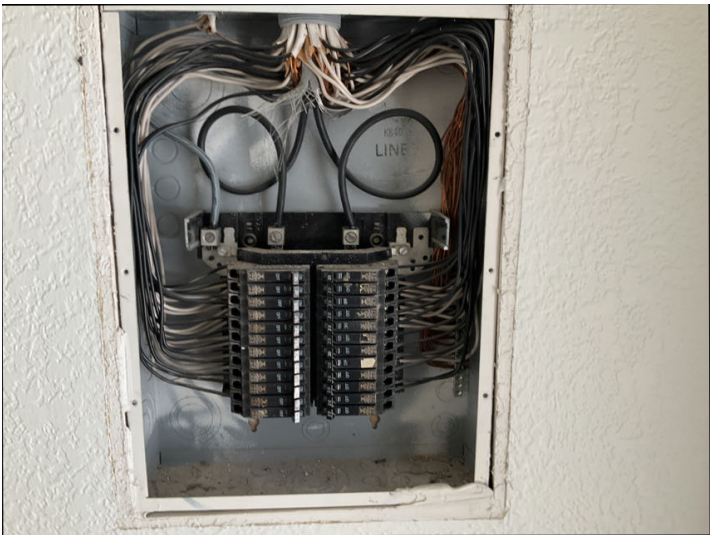
Arc Fault Protection Devices: The house is not equipped with arc fault protection. - The arc faults protection is not up to today's standards which is common to see in an older home.

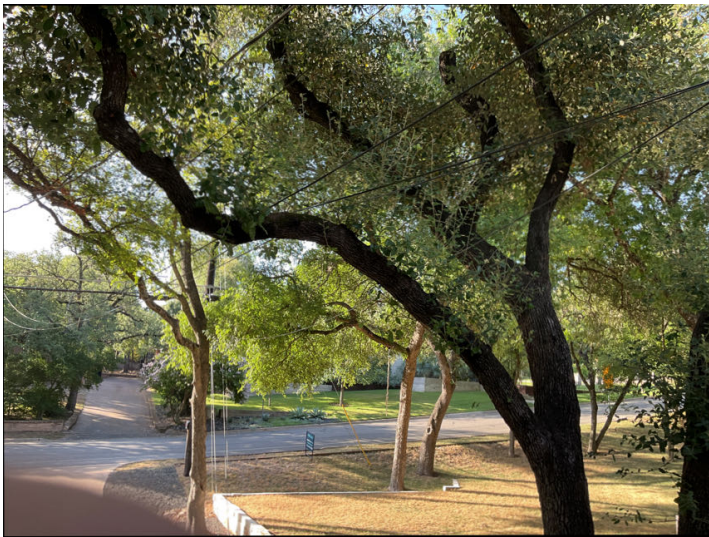
Cable and telephone wires are in contact with tree limbs in one or more locations.

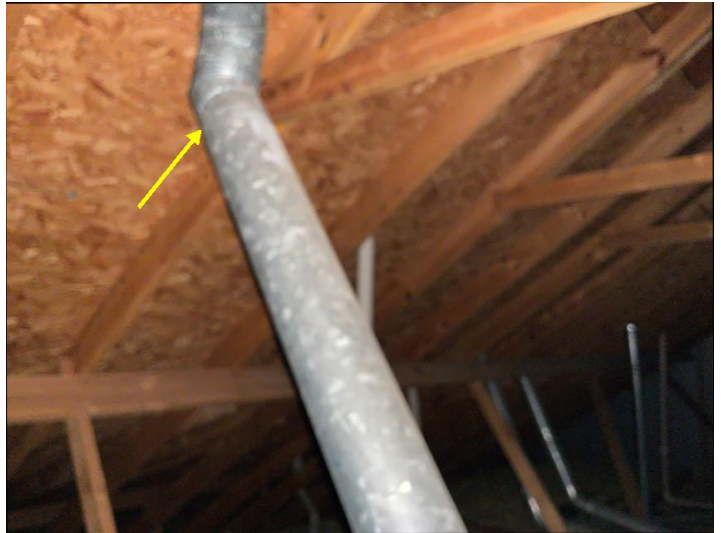
Gas was off at the time of the inspection. The furnaces could not be inspected.

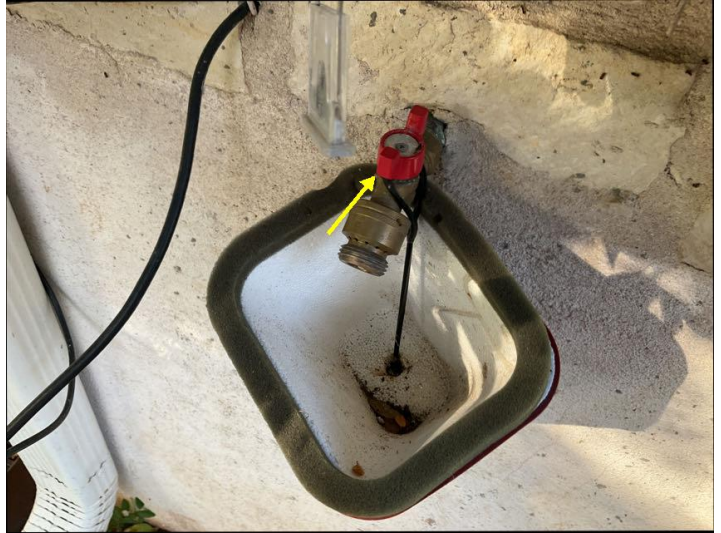
Owners water cut off valve is buried. Recommend cleaning soil from valve housing. Valve housing cover is missing.

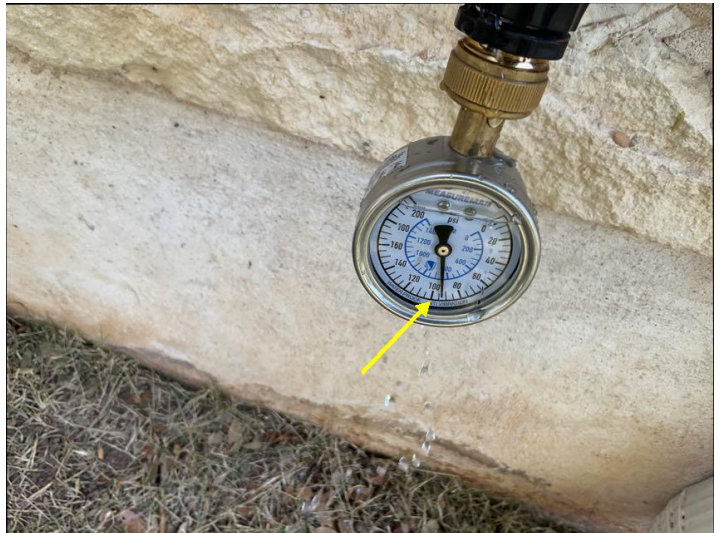
Hose bib vacuum breaker missing: One or more exterior hose bibs should have a vacuum breaker or anti-siphon device. This device prevents water from entering the potable (drinking) water supply.

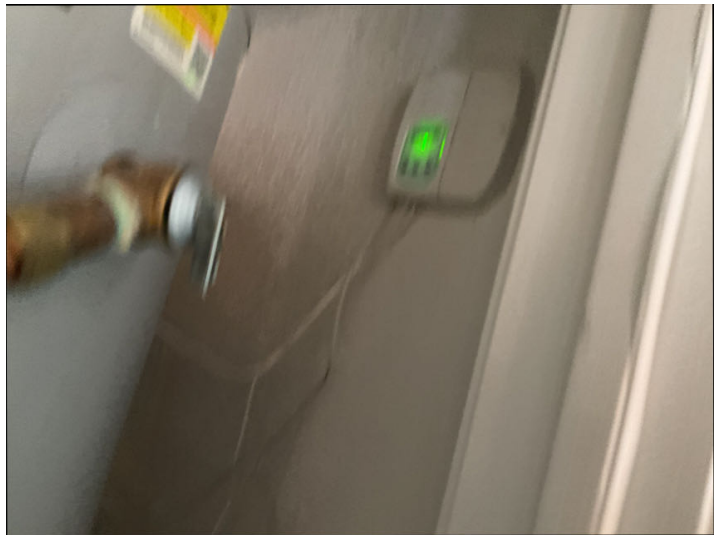
The water heater overflow pan is not connected to a drain line.

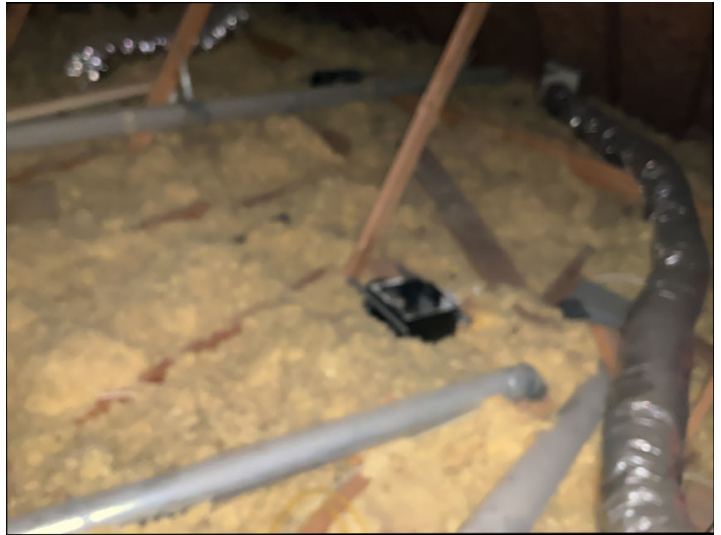
The bath fans are disconnected from the vent pipes and or the vent pipes are not present. Recommend updating to today's standards.

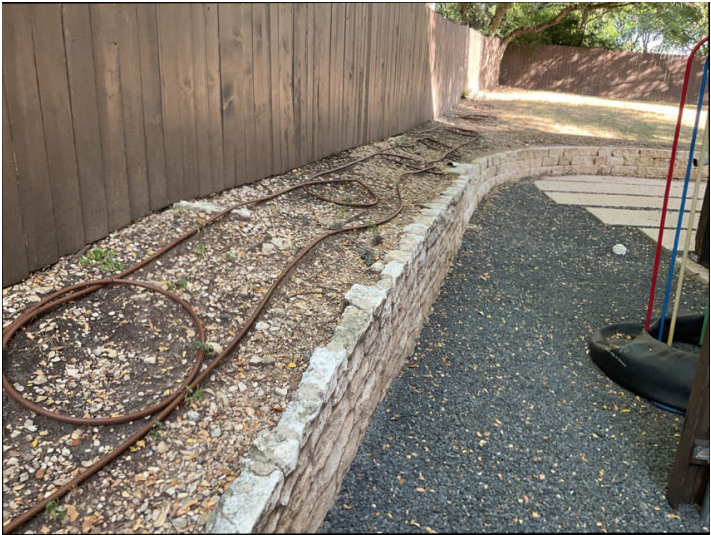
Exposed drip irrigation water lines observed in one or more locations.

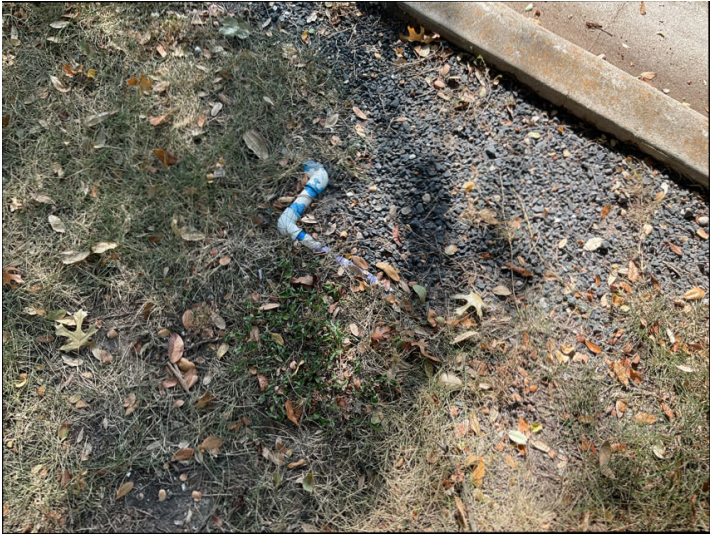
Exposed sprinkler lines observed on the right side of the driveway.
