Precision Inspection

Property Inspection Report

302 Wallis, Rollingwood, TX 78746
Inspection prepared for: Davis & Olivia Baker
Date of Inspection: 7/18/2023 Time: 9:00 AM
Age of Home: 1988 Size: 2950
Weather: Sunny, 100 Degrees
Order ID: 1562

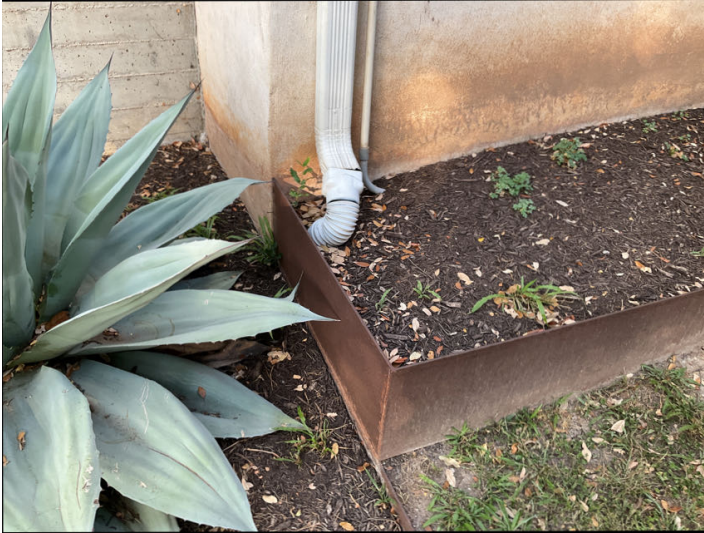
B.1. The gutter and downspout system was observed to be connected to underground drainage piping. Inspector cannot visually inspect the integrity of the underground drain system or proper drainage technique used.

The gutter and downspout system was observed to be connected to underground drainage piping. Inspector cannot visually inspect the integrity of the underground drain system or proper drainage technique used.

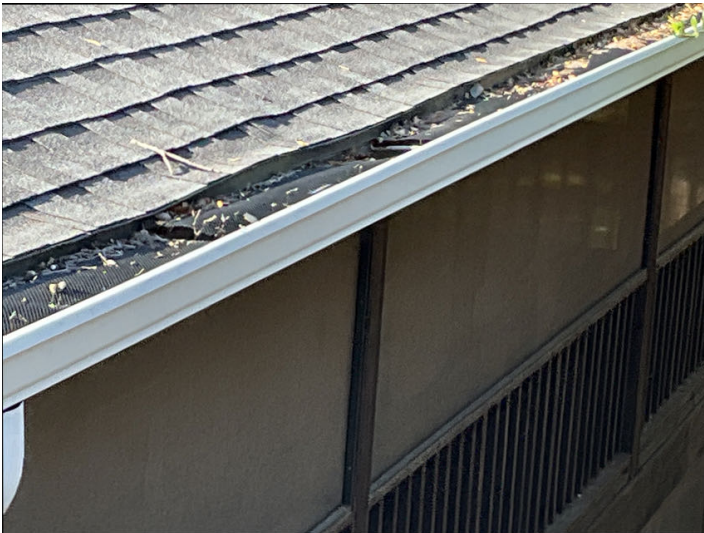
B.4. Gutter guards are sagging and are missing in one or more locations.

Gutter guards are sagging and are missing in one or more locations.

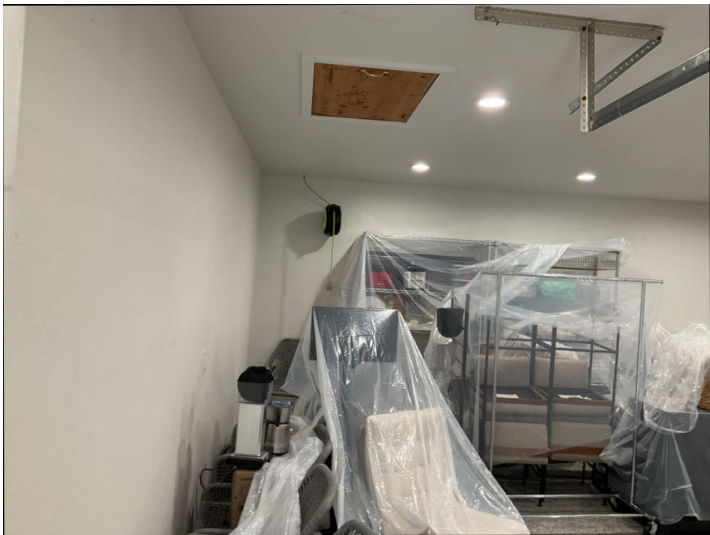
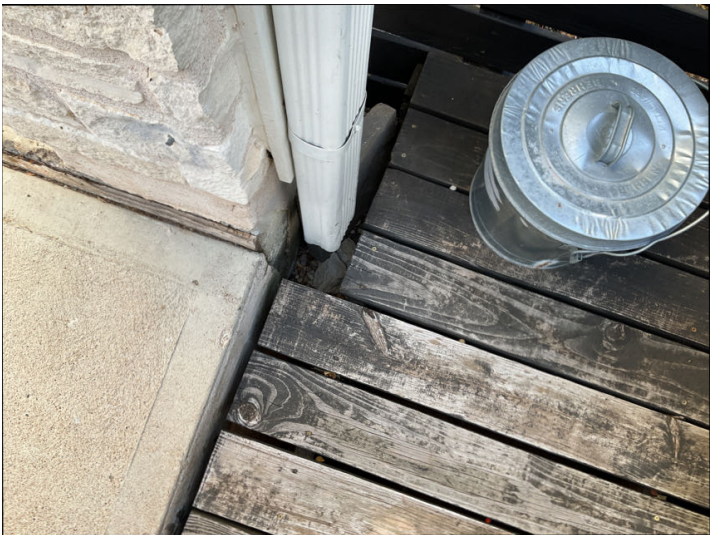
The attic space in the garage cannot be access due to owners belongings in the way at the time of the inspection.

The gutter downspout is missing on the right side of the garage. Recommend installing splash block.

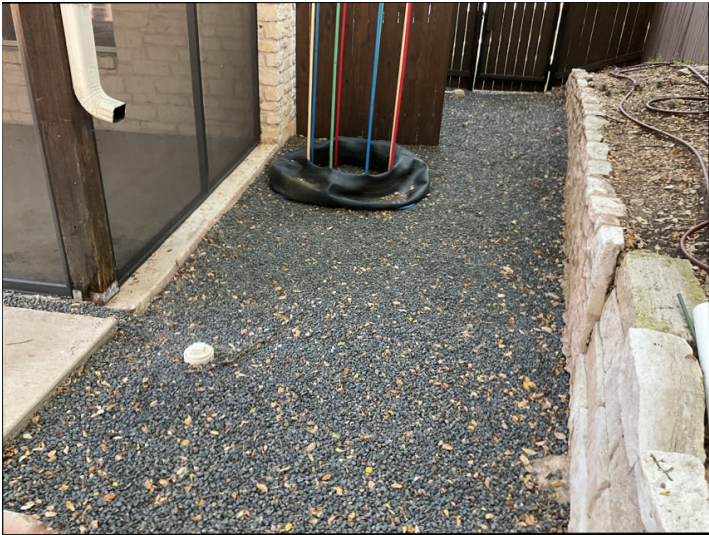
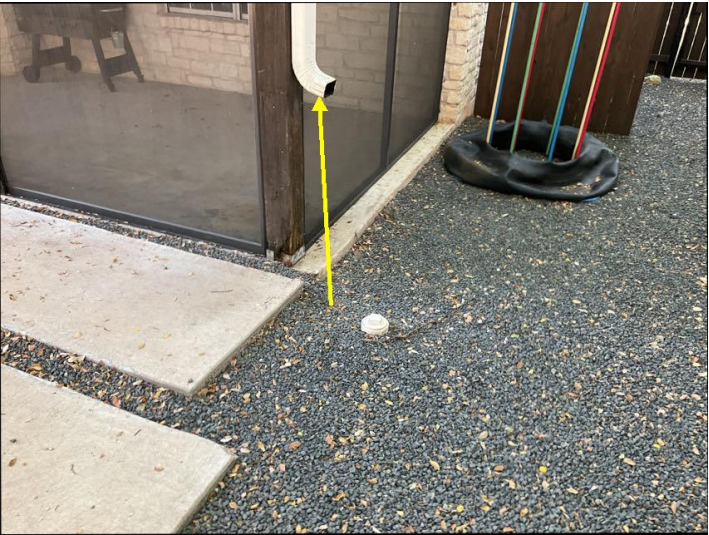
B.2. Negative grade or (poor soil grade) was observed, ground surface slopes towards the foundation or has less than 2% grade away from foundation. To keep surface water from collecting up against and or near the foundation grading should have a 2% slope (6 inches within the first 10 feet) away from the structure.

Negative grade or (poor soil grade) was observed, ground surface slopes towards the foundation or has less than 2% grade away from foundation. To keep surface water from collecting up against and or near the foundation grading should have a 2% slope (6 inches within the first 10 feet) away from the structure.

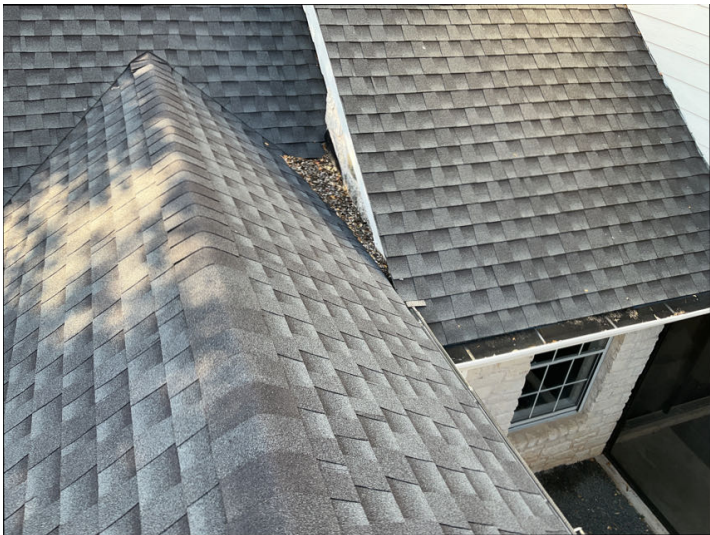
C.3. Debris on the roof surface observed in one or more locations.

Debris on the roof surface observed in one or more locations.

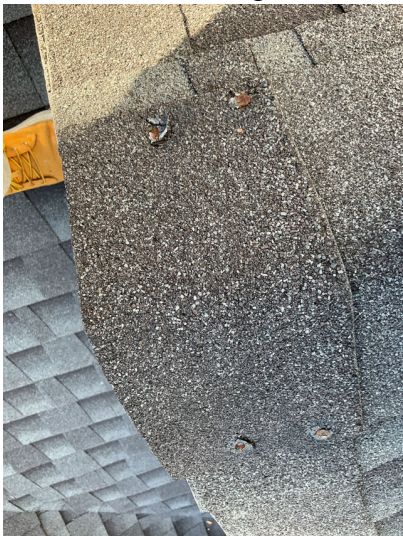
C.2. There are exposed fasteners on the roof. Sealant should be applied to exposed fastener heads to prevent moisture from penetrating the roof in those areas.

There are exposed fasteners on the roof. Sealant should be applied to exposed fastener heads to prevent moisture from penetrating the roof in those areas.

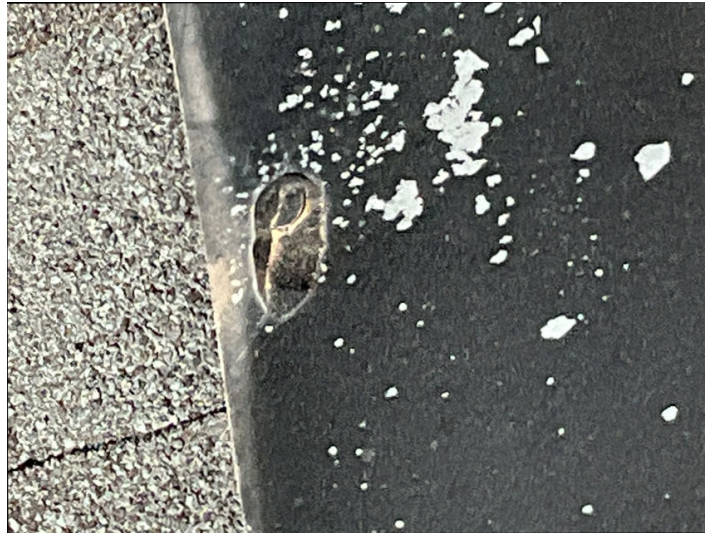
C.5. There are exposed fasteners on the roof. Sealant should be applied to exposed fastener heads to prevent moisture from penetrating the roof in those areas.

There are exposed fasteners on the roof. Sealant should be applied to exposed fastener heads to prevent moisture from penetrating the roof in those areas.

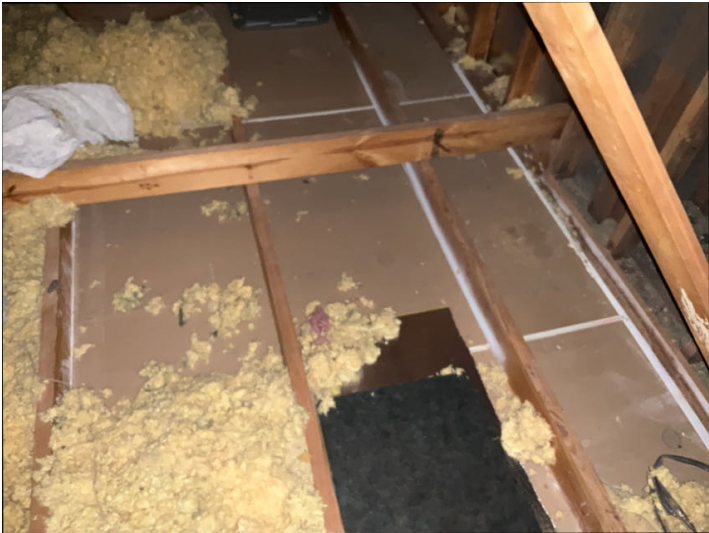
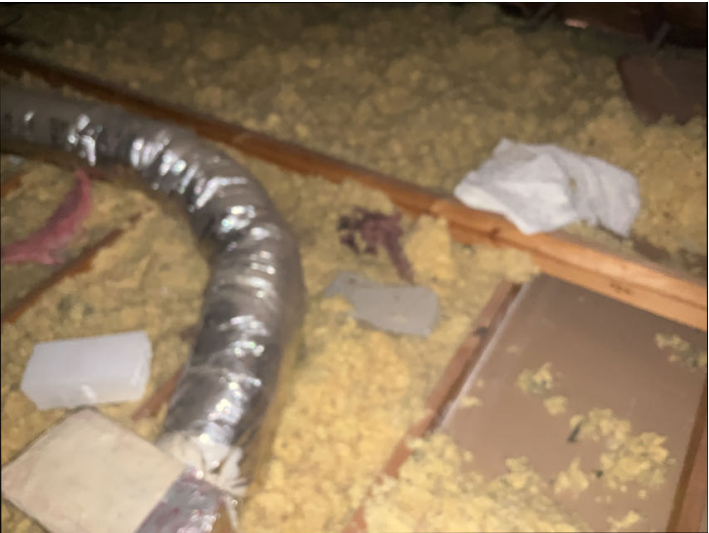
D.3. Attic insulation is missing in one or more locations.

Attic insulation is missing in one or more locations. Attic insulation is missing in one or more locations.

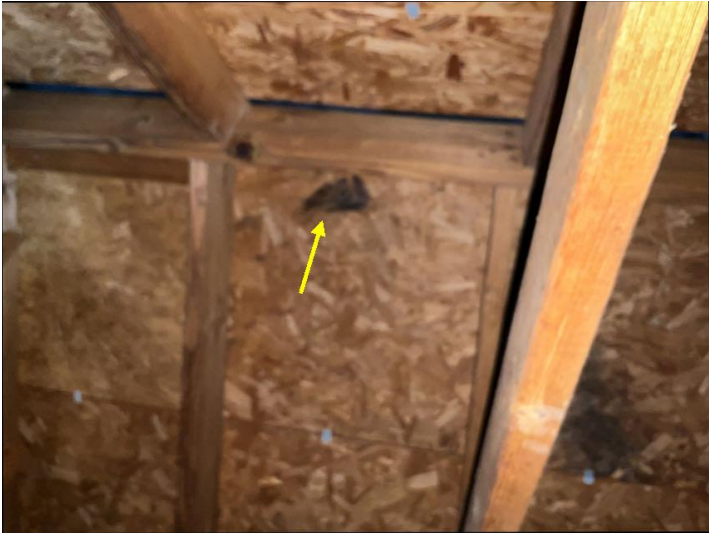
D.4. Water stains observed on roof decking in one or more locations.

Water stains observed on roof decking in one or more locations.

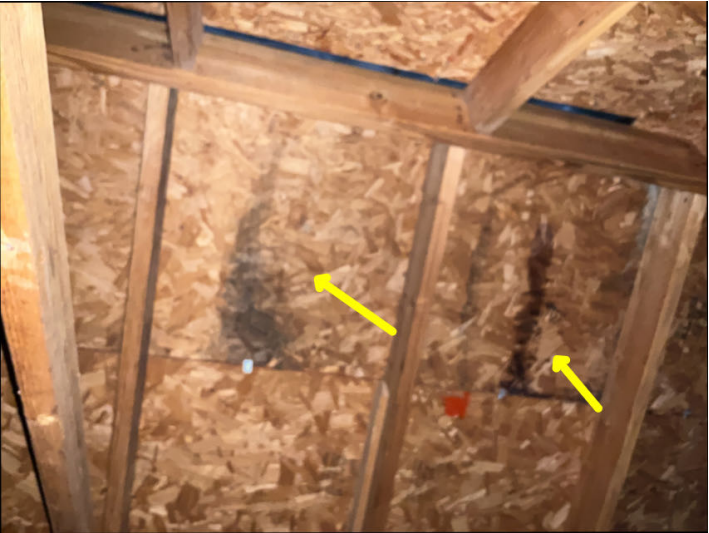
Water stains observed on roof decking in one or more locations.

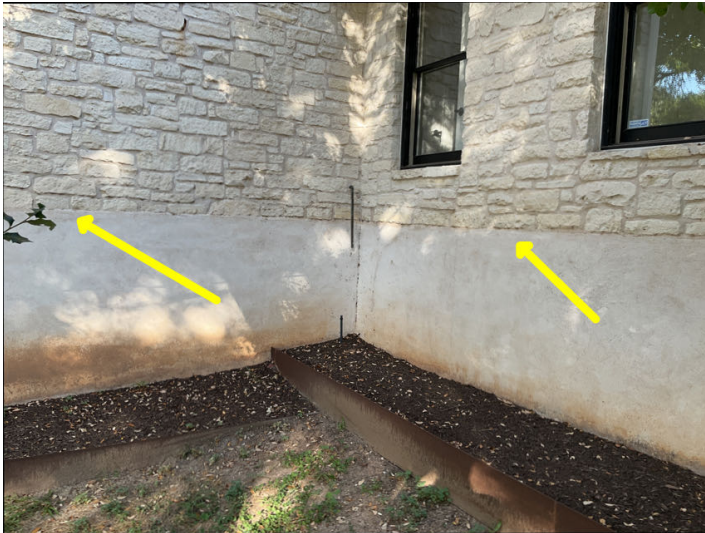
Lack of weep holes installed in Exterior rock veneer at the rock perimeter footing ledge. Common to see an older homes.

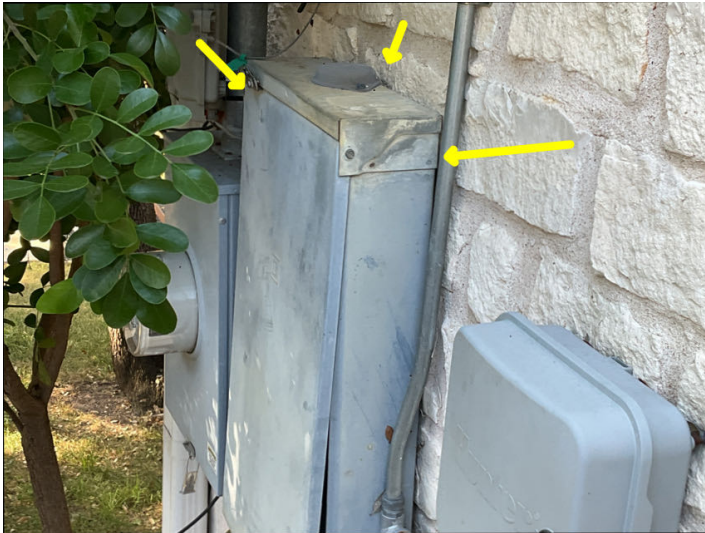
E.5. Exterior wall penetrations have missing and or separated sealants (caulking).

Exterior wall penetrations have missing and or separated sealants (caulking).

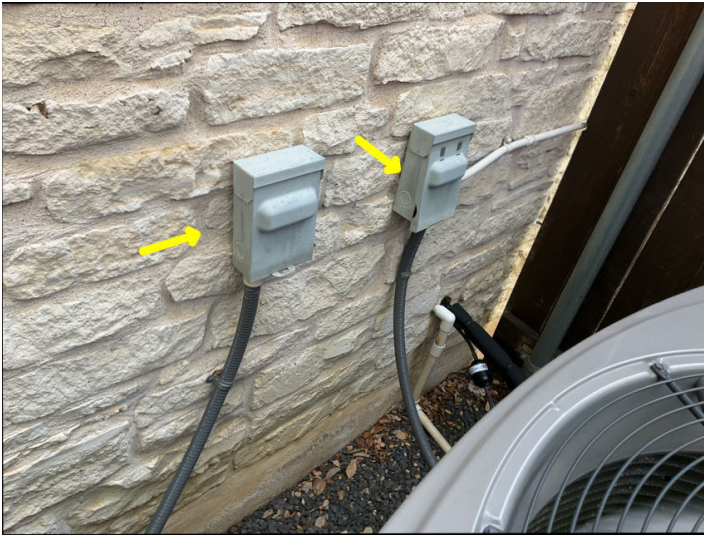
Exterior wall penetrations have missing and or separated sealants (caulking).

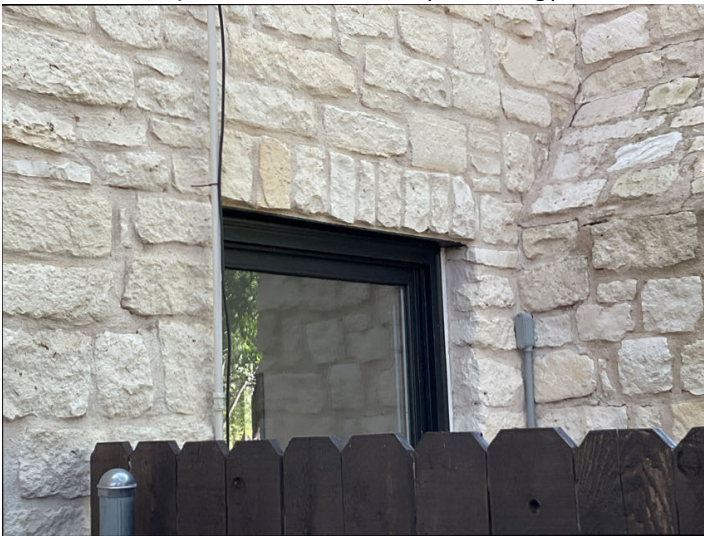
Lack of weep holes in rock mortar above windows. Common to see you on older homes.

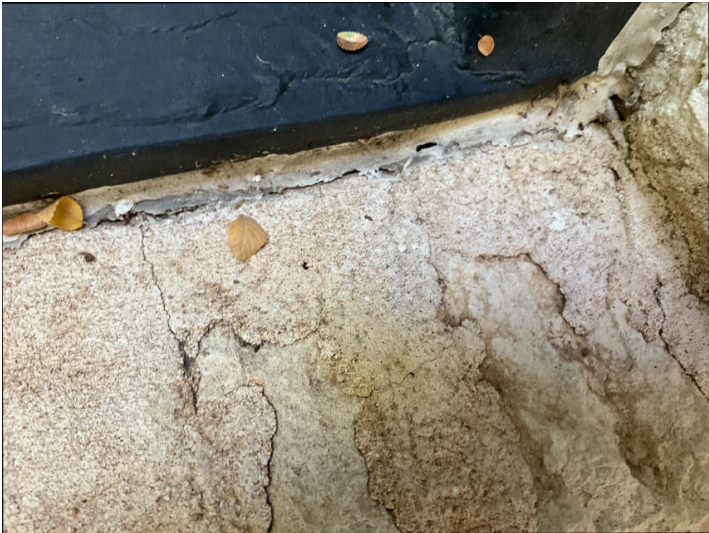
E.6. -Exterior window trim has missing or deteriorated sealants (caulking) where the window frame meets the wall cladding and or trim.

-Exterior window trim has missing or deteriorated sealants (caulking) where the window frame meets the wall cladding and or trim.

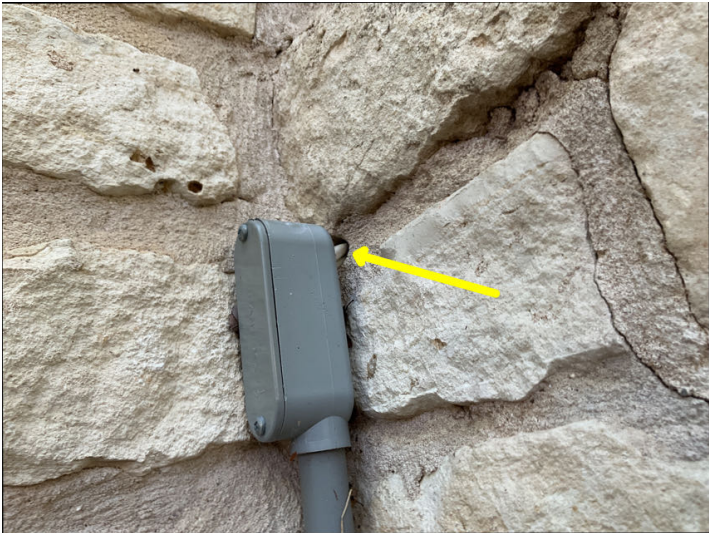
Exterior wall penetrations have missing and or separated sealants (caulking).

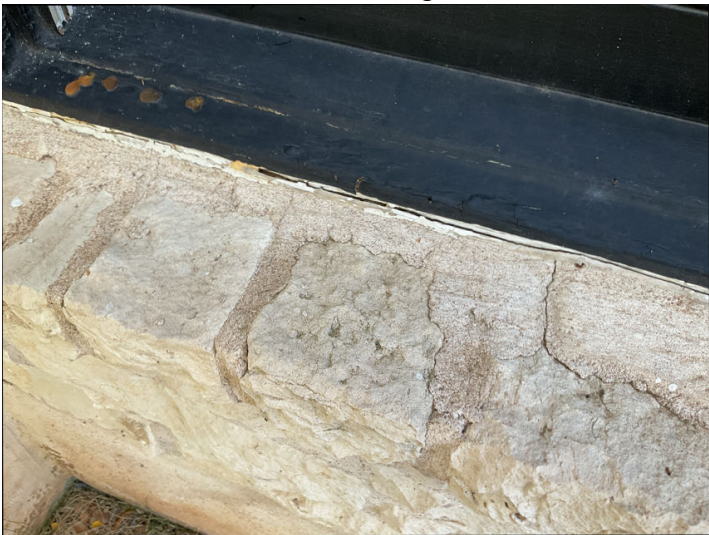
-Exterior window trim has missing or deteriorated sealants (caulking) where the window frame meets the wall cladding and or trim.

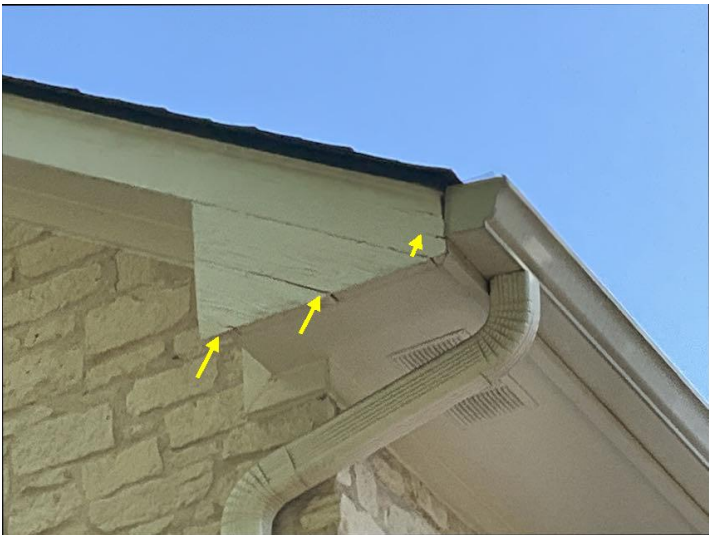
Wood fascia trim is checking and or splitting in one or more locations.

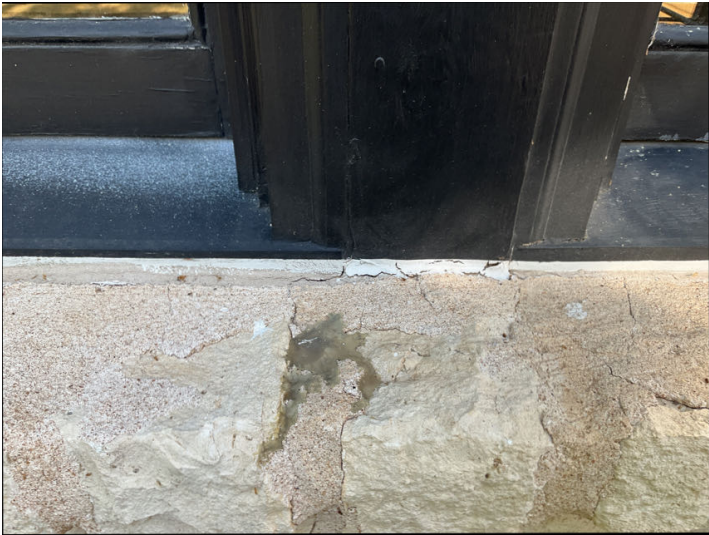
-Exterior window trim has missing or deteriorated sealants (caulking) where the window frame meets the wall cladding and or trim.

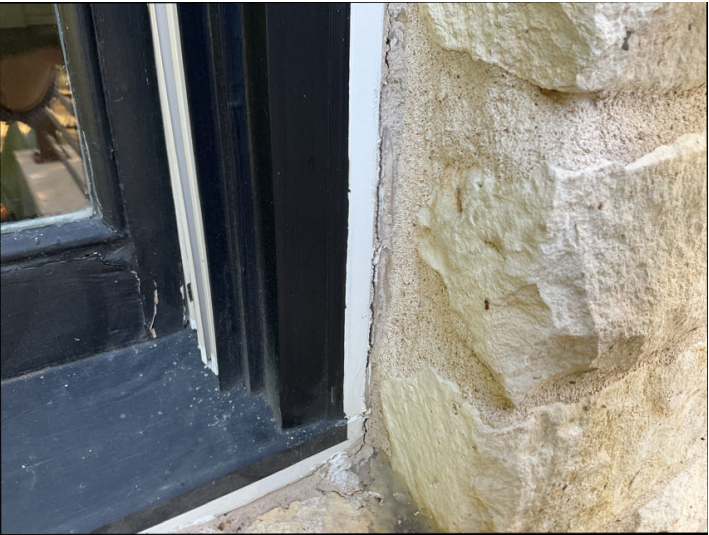
-Exterior window trim has missing or deteriorated sealants (caulking) where the window frame meets the wall cladding and or trim.

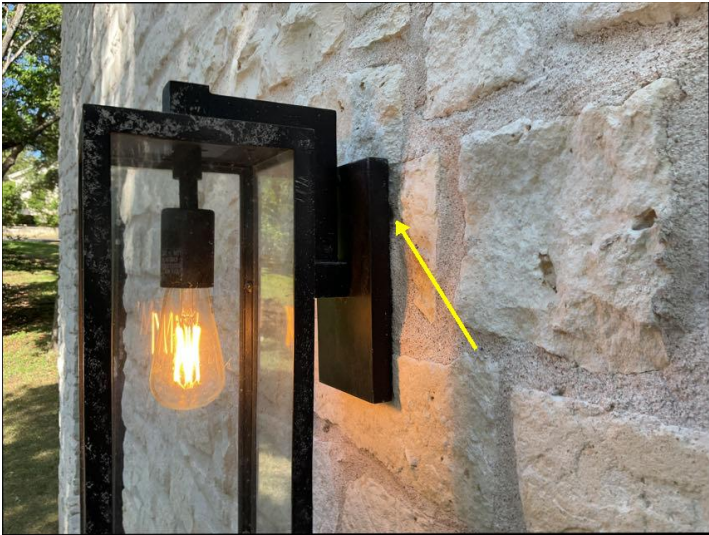
Exterior wall penetrations have missing and or separated sealants (caulking).

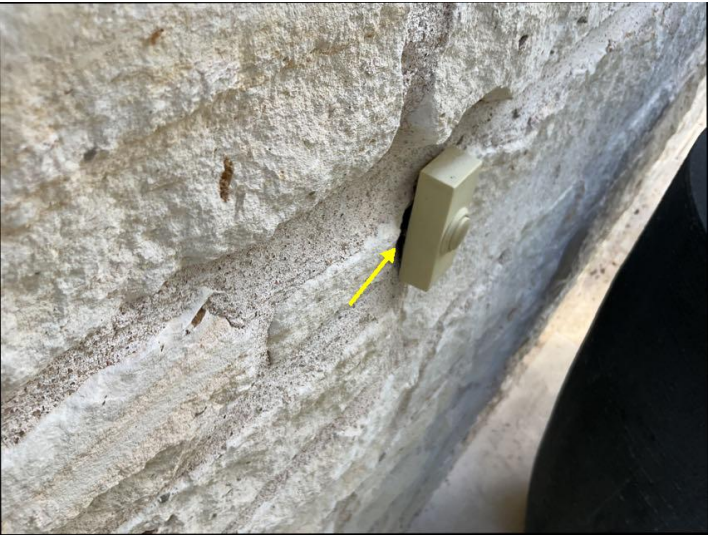
Exterior wall penetrations have missing and or separated sealants (caulking).

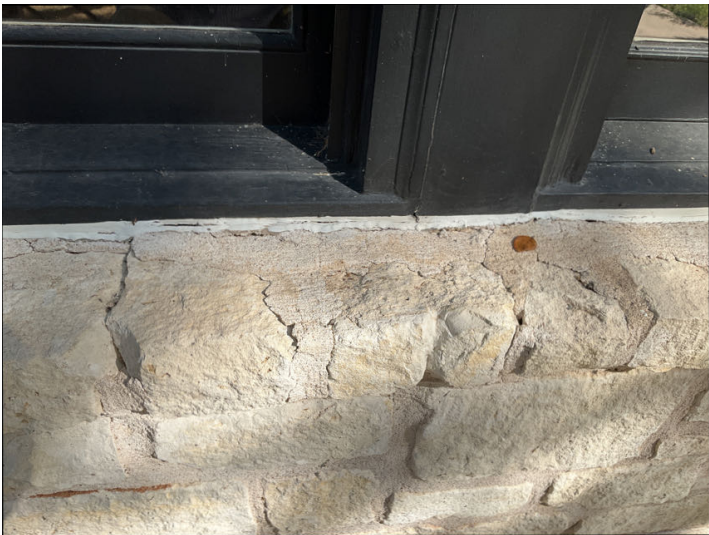
-Exterior window trim has missing or deteriorated sealants (caulking) where the window frame meets the wall cladding and or trim.

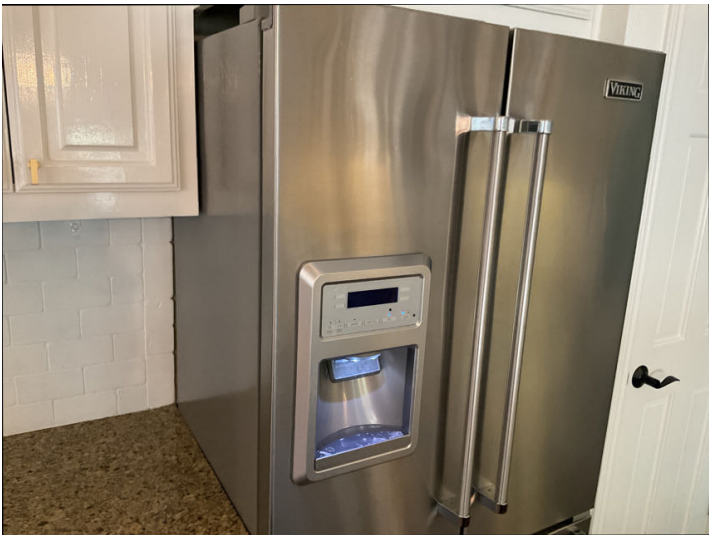
Built-in type of refrigerator. The walls and water lines behind the refrigerator we're not inspected.

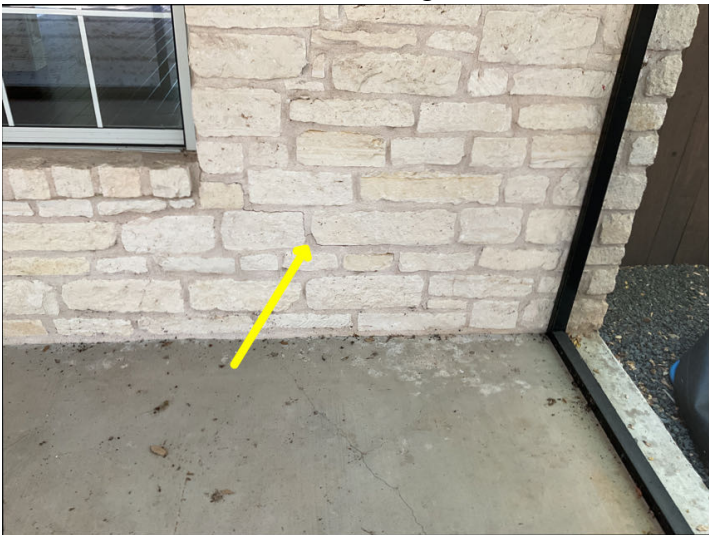
E.13. Stair step crack in rock mortar on back patio left side of the strucutre.

Stairstep crack in rock mortar on back patio right side.

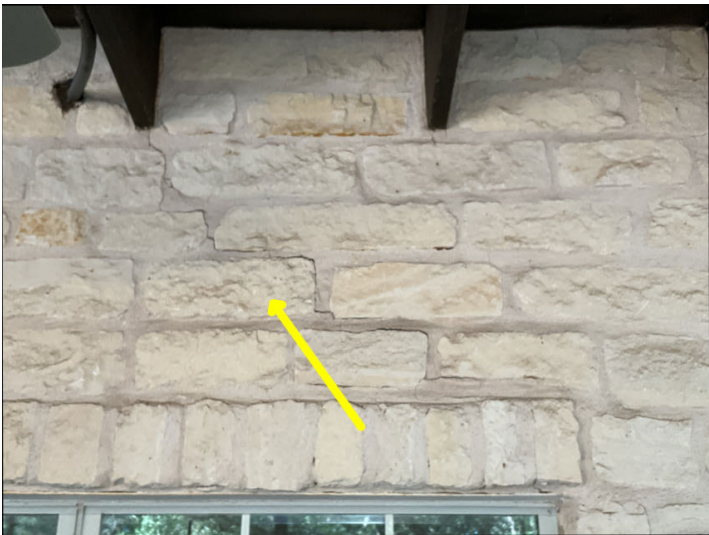
Stairstep crack in rock mortar on back patio right side.

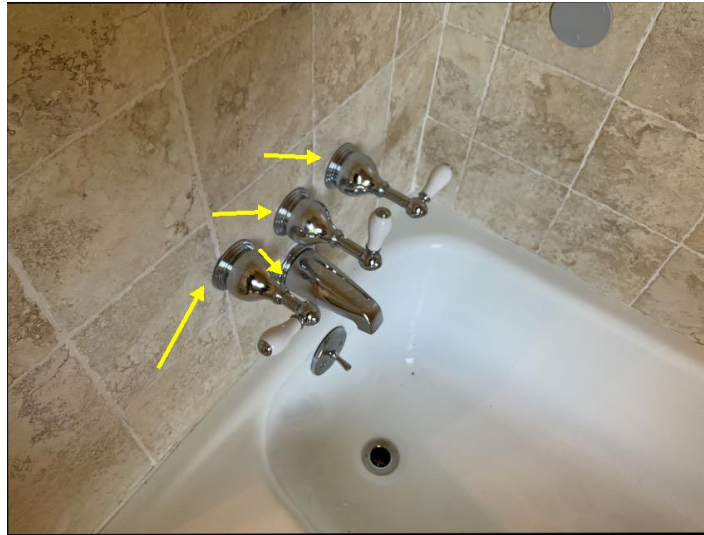
E.7. The bathtub and/or shower fixtures are not properly sealed to the wall in one or more locations. The escutcheons and fixtures should be sealed to the wall to prevent moisture penetration in those areas.

The bathtub and/or shower fixtures are not properly sealed to the wall in one or more locations. The escutcheons and fixtures should be sealed to the wall to prevent moisture penetration in those areas.

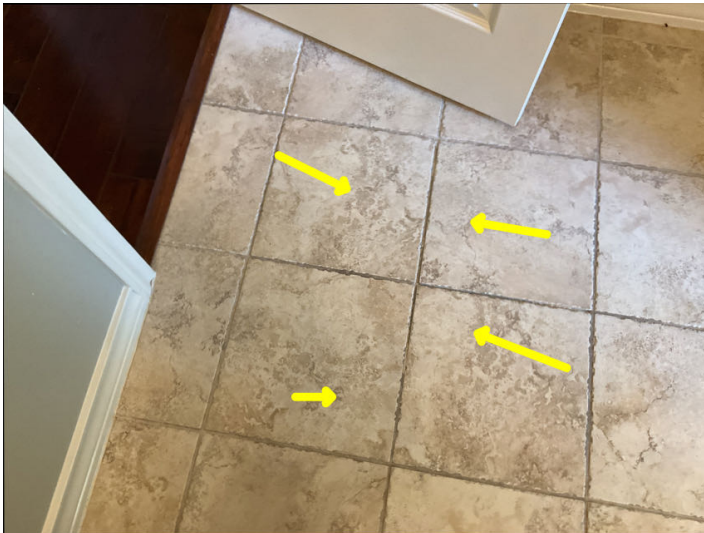
upstairs hall bathroom ceramic floor tile grout is missing and are cracked. Flores lifted in this area.

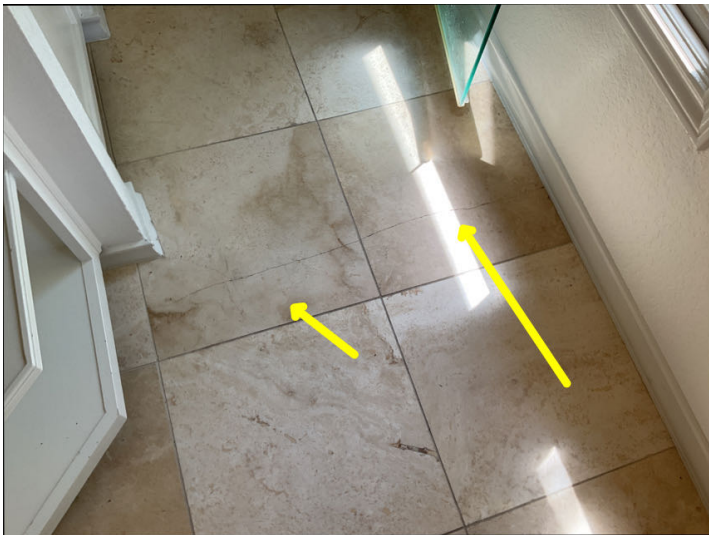
F.4. One or more cracked floor tiles observed in primary bathroom floor.

One or more cracked floor tiles observed in primary bathroom floor.

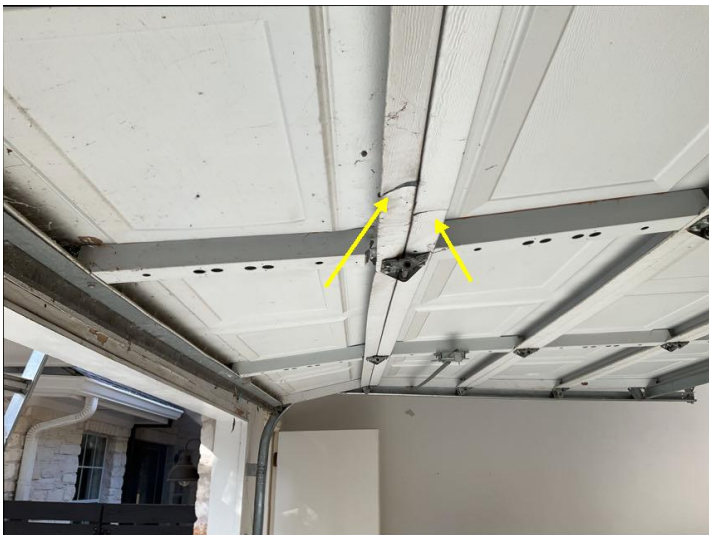
The garage door metal panels are damaged in one or more locations.

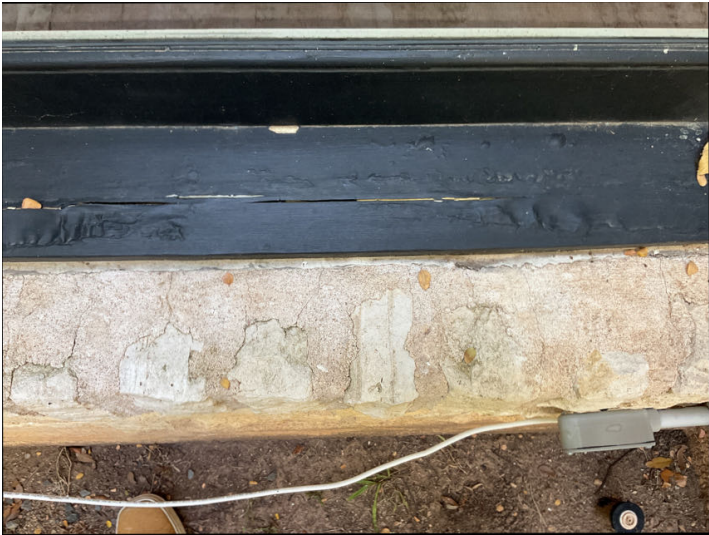
One or more wood sash window shows signs of water damage and or wood rot. Previous repairs.

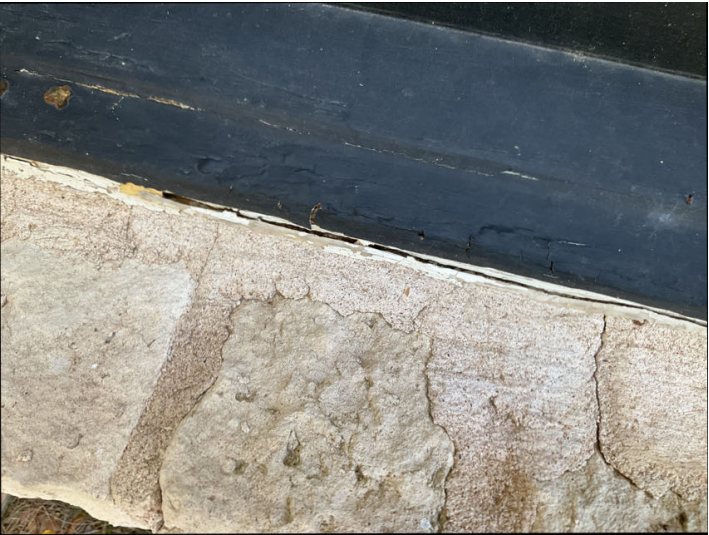
One or more wood sash window shows signs of water damage and or wood rot. Previous repairs.

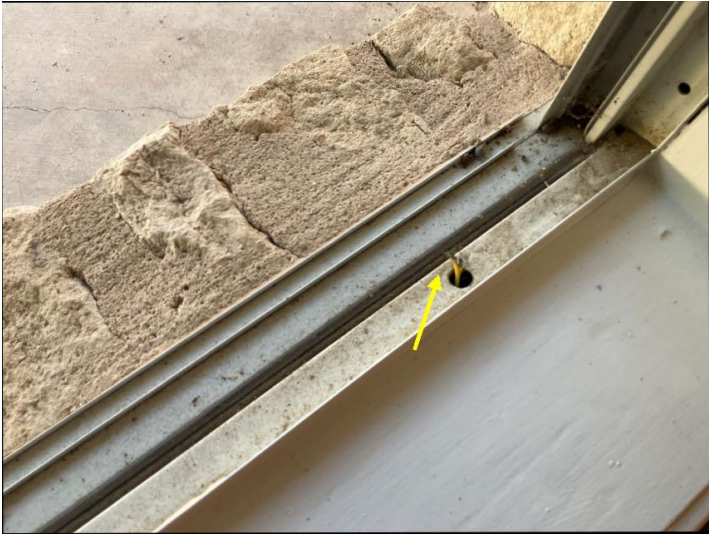
Window frames have been drilled on the exterior bottom on the frame for security sensors. Drill holes can allow water to enter into the wall envelope. Hole for sensors should be properly sealed to prevent water and or moisture from entering the wall envelope.

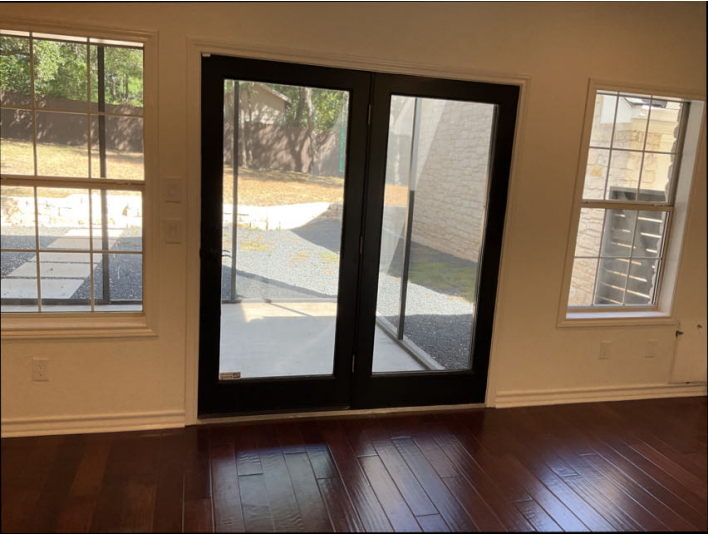
Windows on both sides of the back right door or not labeled as safety of tempered glass. Should be tempered glass When within 24 inches of the opening of the door

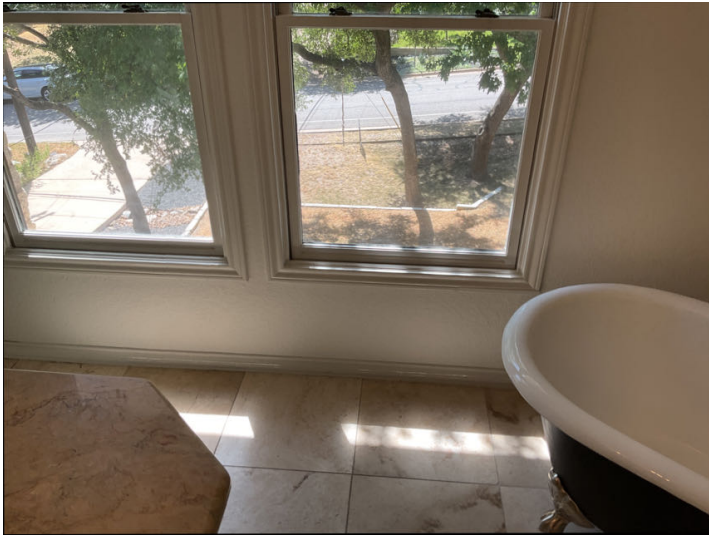
Windows located in the primary bathroom are Labeled as safety or tempered glass. Installed and wet location.

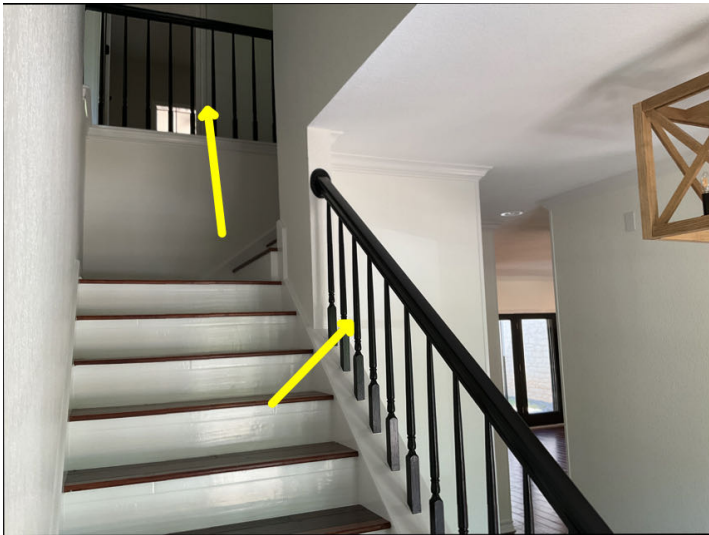
The interior stairs balusters are more than 4 inches apart known as a child safety hazard.

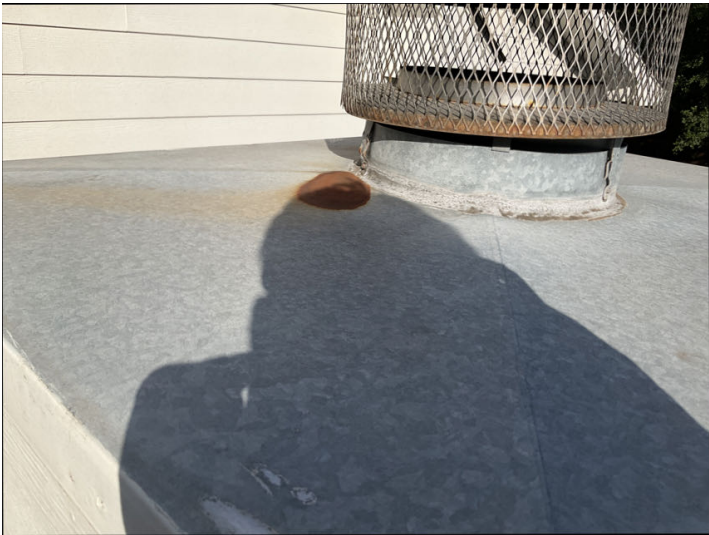
J.2. One one or more chimneys. Metal is rusty: The metal crown or cover at the top of the chimney is shows signs of excessive rust.
Holes or pits in the metal may develop, which in turn may allow water into the chimney chase.

One one or more chimneys. Metal is rusty: The metal crown or cover at the top of the chimney is shows signs of excessive rust.
Holes or pits in the metal may develop, which in turn may allow water into the chimney chase.

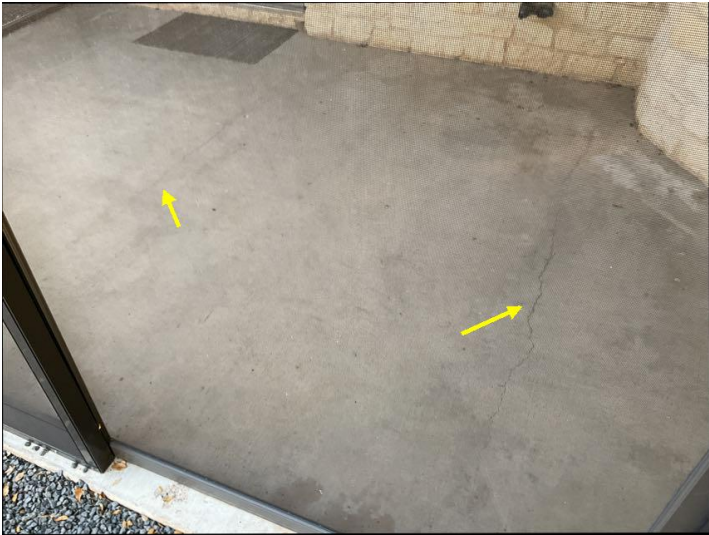
Cracks observed in back patio concrete services in one or more locations.

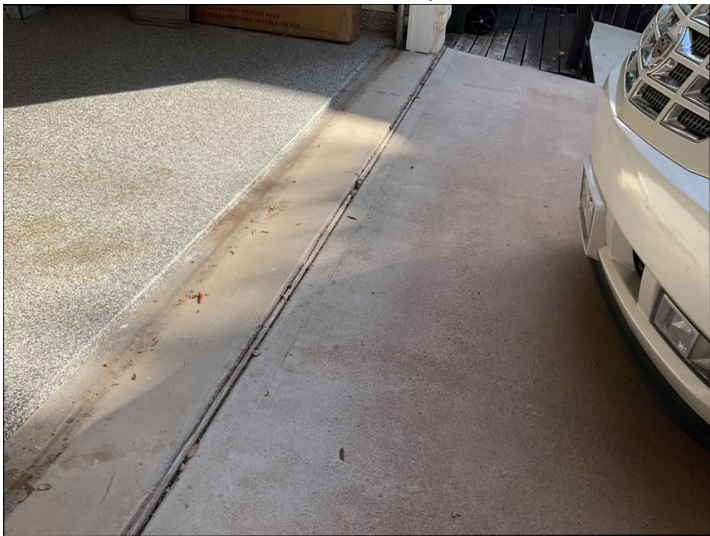
The driveway has settled at the garage opening.

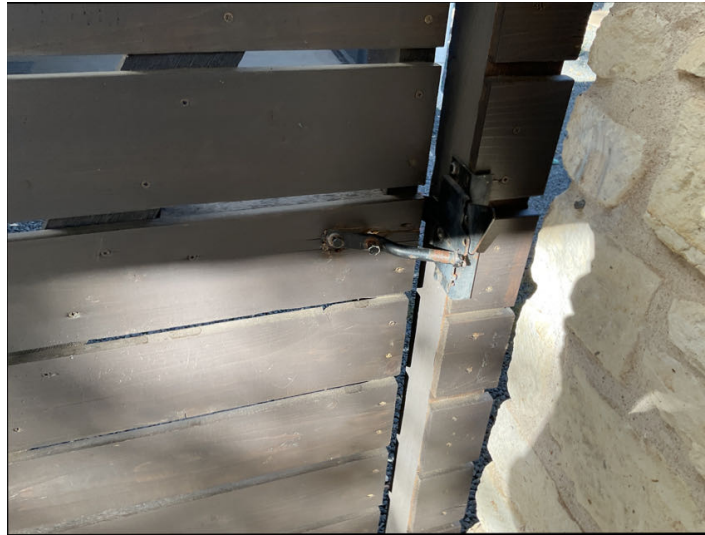
The right side wooden gate would not latch, lock or close properly.

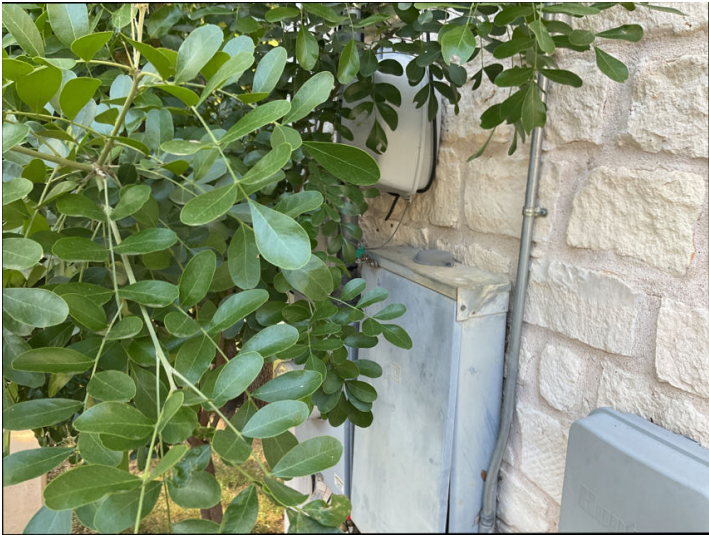
The electrical panel should have 30 inch clearance on both sides and 36 inch clearance in front of the electrical panel.

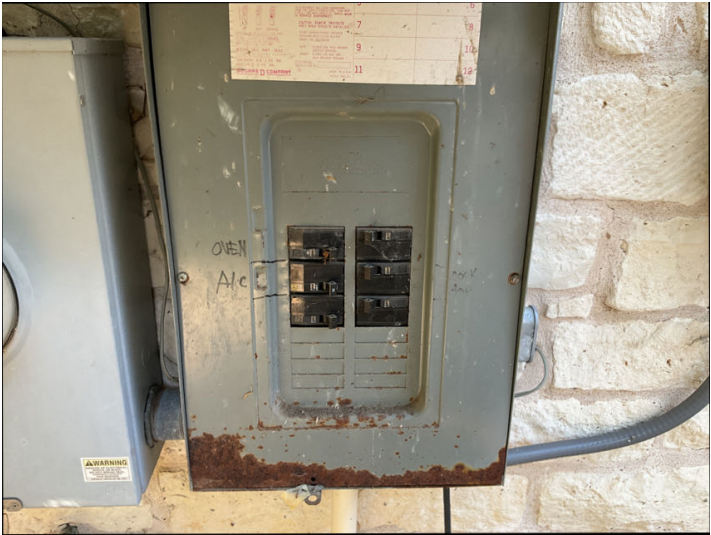
The main electrical panel box is not equipped with a main disconnect. Should have a main disconnect when six or more breakers are present.

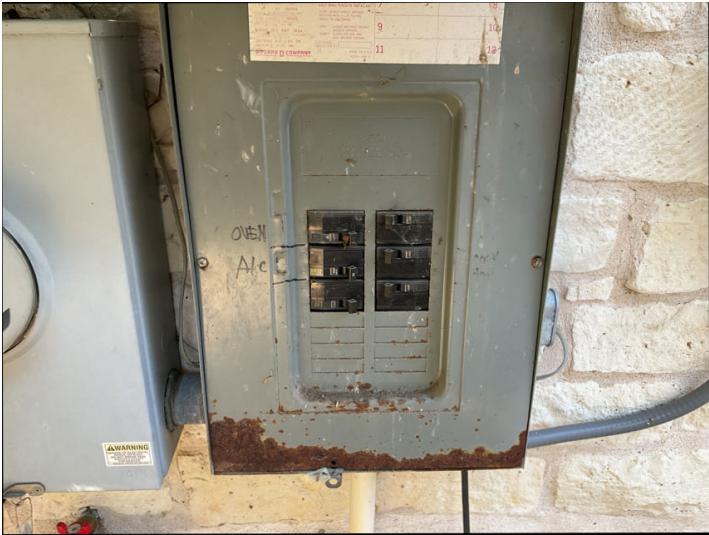
A.7. The panel box dead front cover screws should be blunt tipped. Safety hazard.

The panel box dead front cover screws should be blunt tipped. Safety hazard.

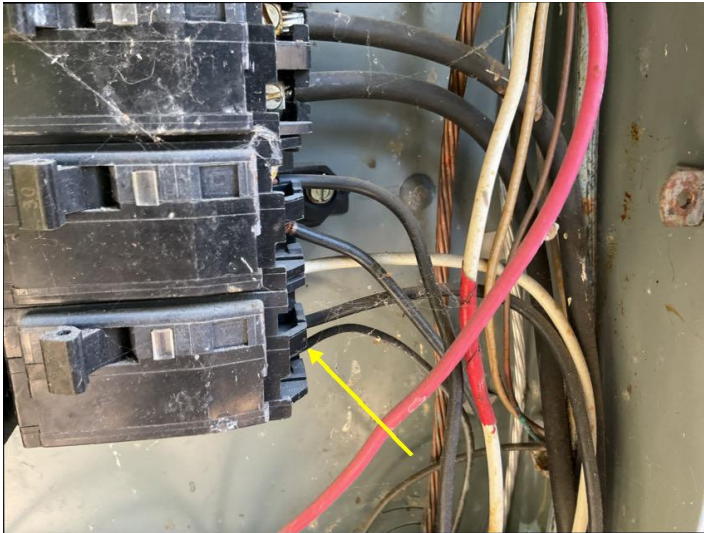
A.6. A 30 amp and 50 amp Breakers are double lugged. Two wires connected to the breaker. Both have one wire that's undersized for the breaker size. Fire safety hazard.

A 30 amp and 50 amp Breakers are double lugged. Two wires connected to the breaker. Both have one wire that's undersized for the breaker size. Fire safety hazard.

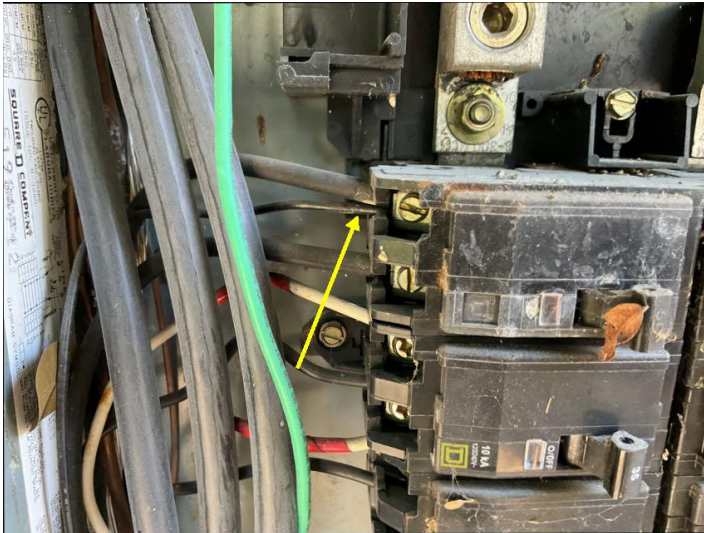
A 30 amp and 50 amp Breakers are double lugged. Two wires connected to the breaker. Both have one wire that's undersized for the breaker size. Fire safety hazard.

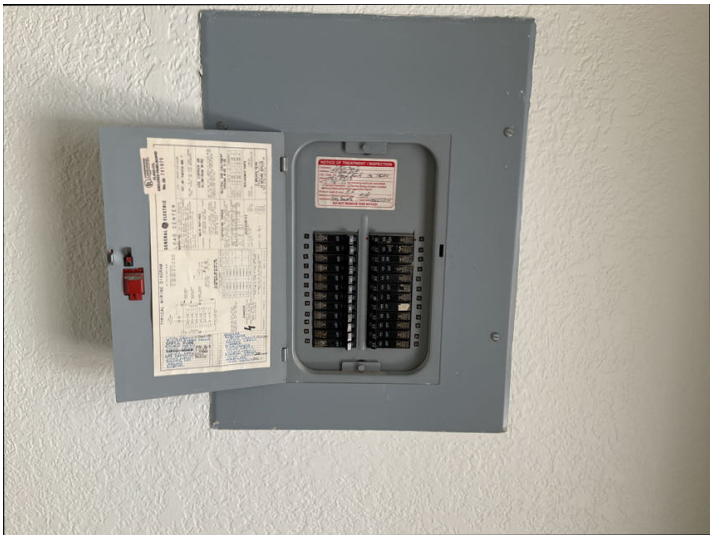
Arc Fault Protection Devices: The house is not equipped with arc fault protection. - The arc faults protection is not up to today's standards which is common to see in an older home.

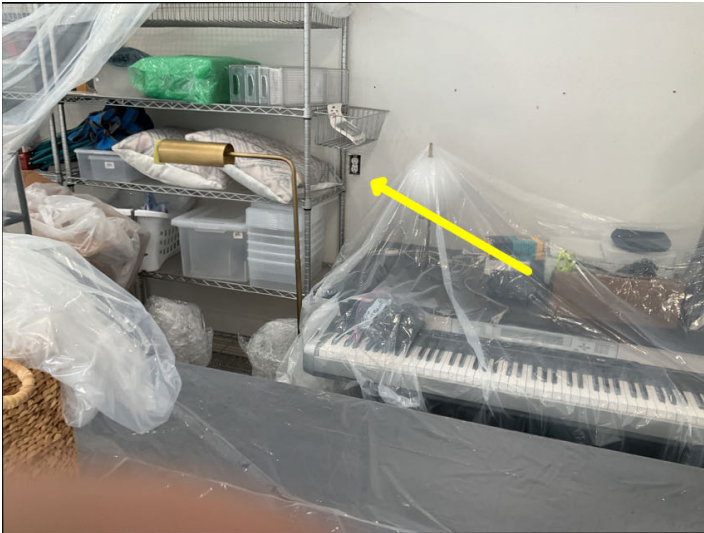
One or more electrical receptacles in the garage cannot be inspected due to owners belongings in the way

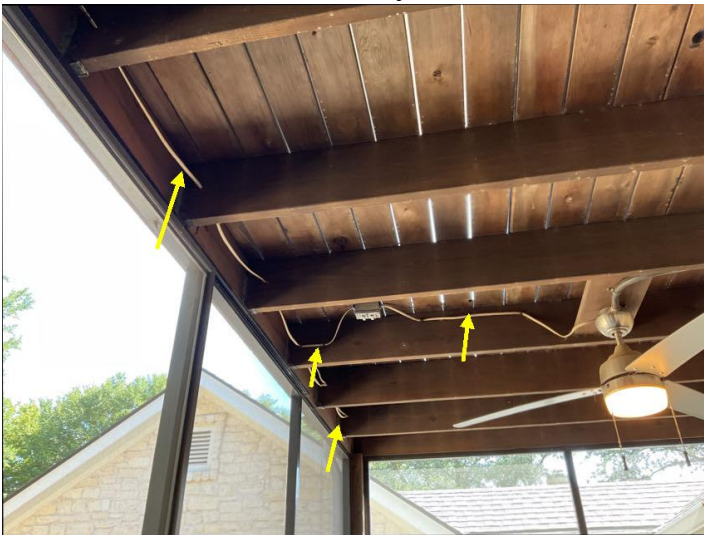
Back patio ceiling fan expose Romax wire should be in conduit.

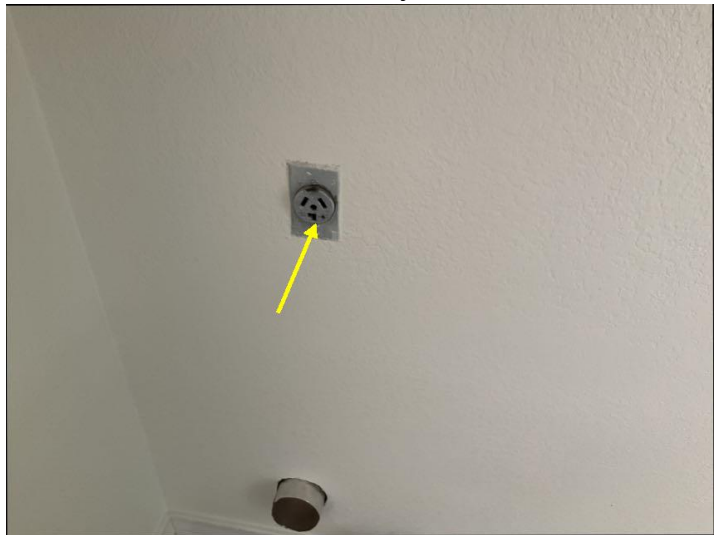
Clothes dryer electrical receptacle is a 3 prong receptacle without a ground. Newer dryers use a 4 prong receptacle. May need to update the receptacle for your dryer.

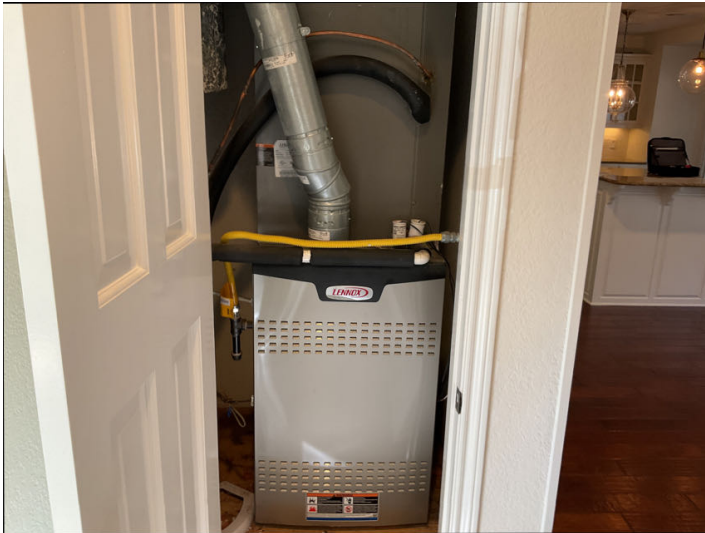
Gas was off at the time of the inspection. The furnaces could not be inspected.

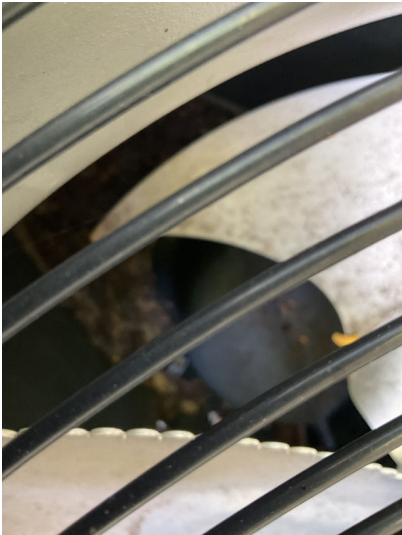
B.1. Leaf and debris observed in both AC condensing units. Recommend having a unit serviced and cleaned.

Leaf and debris observed in both AC condensing units. Recommend having a unit serviced and cleaned.

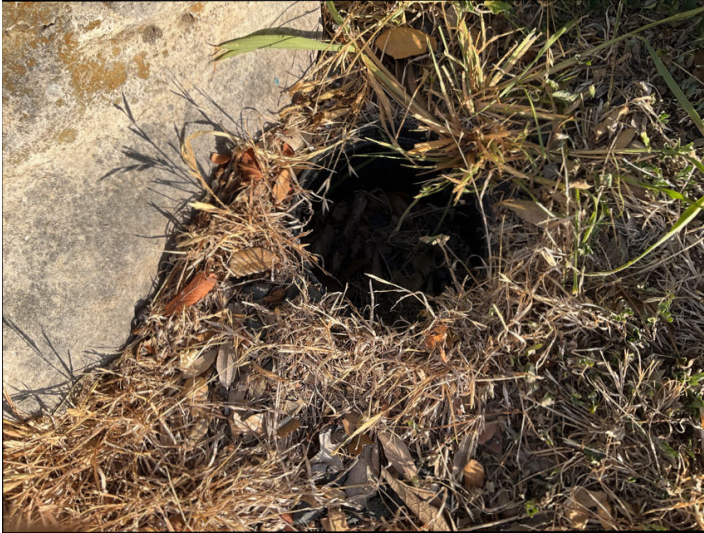
A.2. Owners water cut off valve is buried. Recommend cleaning soil from valve housing. Valve housing cover is missing.

Owners water cut off valve is buried. Recommend cleaning soil from valve housing. Valve housing cover is missing.
