Precision Inspection

Property Inspection Report

302 Wallis, Rollingwood, TX 78746
Inspection prepared for: Davis & Olivia Baker
Date of Inspection: 7/18/2023 Time: 9:00 AM
Age of Home: 1988 Size: 2950
Weather: Sunny, 100 Degrees
Order ID: 1562

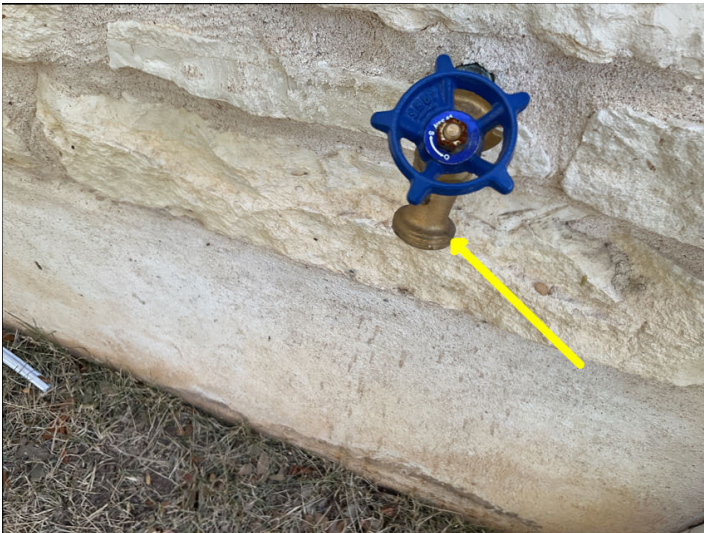
A.3. Hose bib vacuum breaker missing: One or more exterior hose bibs should have a vacuum breaker or anti-siphon device. This device prevents water from entering the potable (drinking) water supply.

Hose bib vacuum breaker missing: One or more exterior hose bibs should have a vacuum breaker or anti-siphon device. This device prevents water from entering the potable (drinking) water supply.

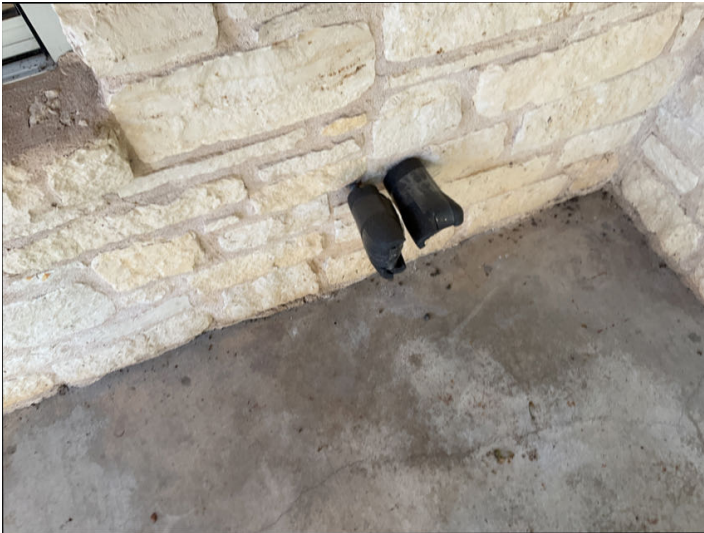
Back porch exterior pipes and your faucets we're not inspected due to insulation installed over pipes

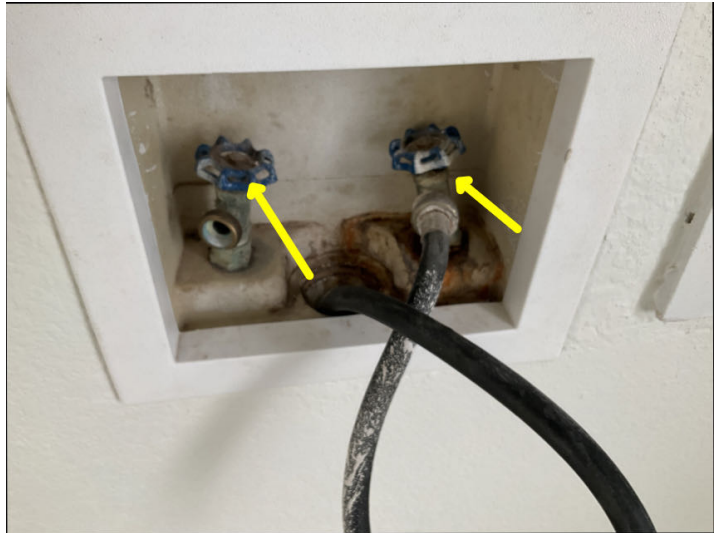
A.7. Washer supply hose bib Lines leak at the valve stems when opened.

Washer supply hose bib Lineslook at the valve stems when I opened.

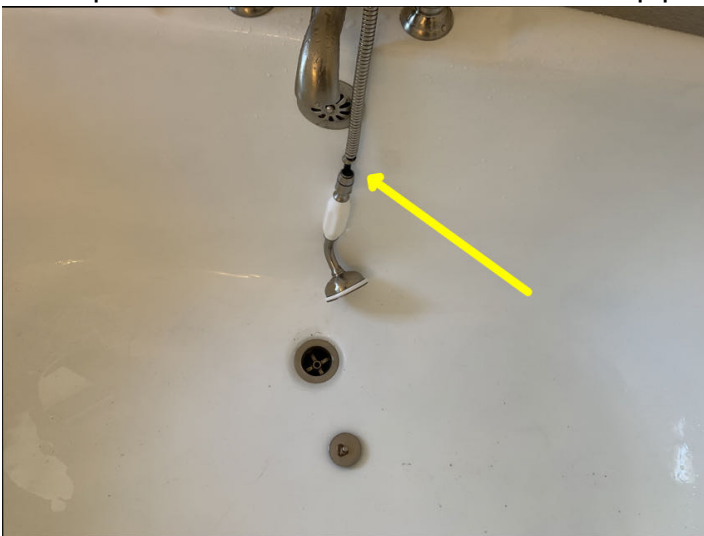
A.8. The primary bathroom tub spray wand hose is damaged. Water leaks from the house when turned on.

The primary bathroom tub spray wand hose is damaged. Water leaks from the house when turned on.

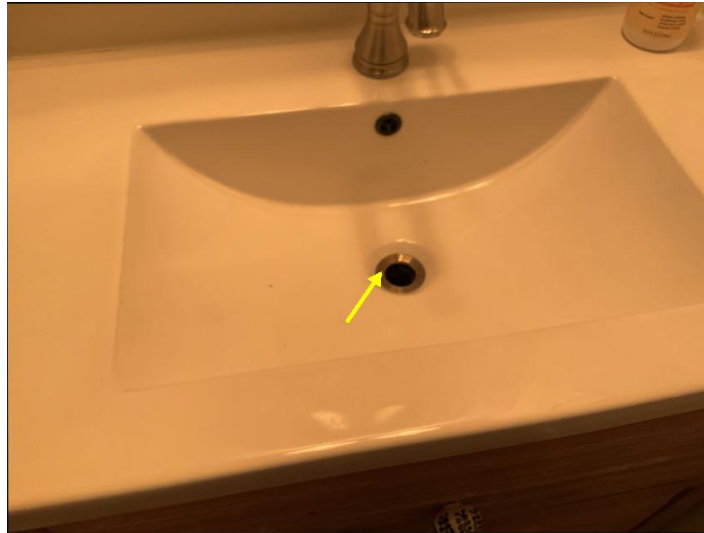
B.2. Downstairs bathroom vanity sink drain stopper is missing.

Downstairs bathroom vanity sink drain stopper is missing.

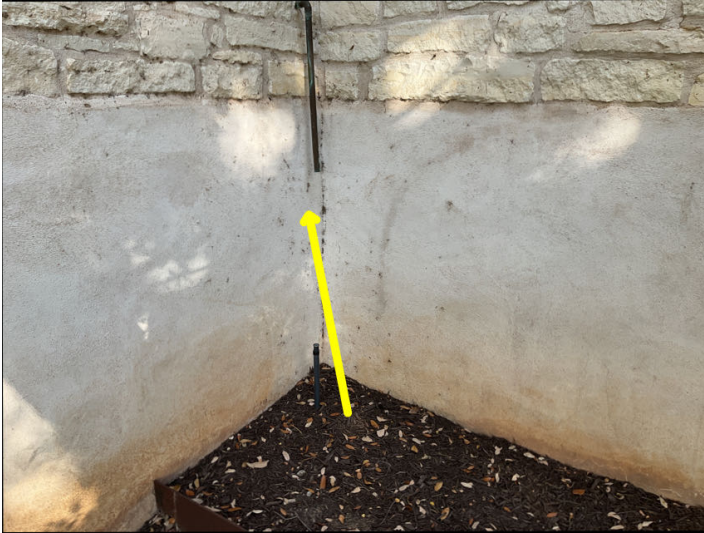
Water heater temperature and pressure drain line to terminate within 6 inches of the ground.

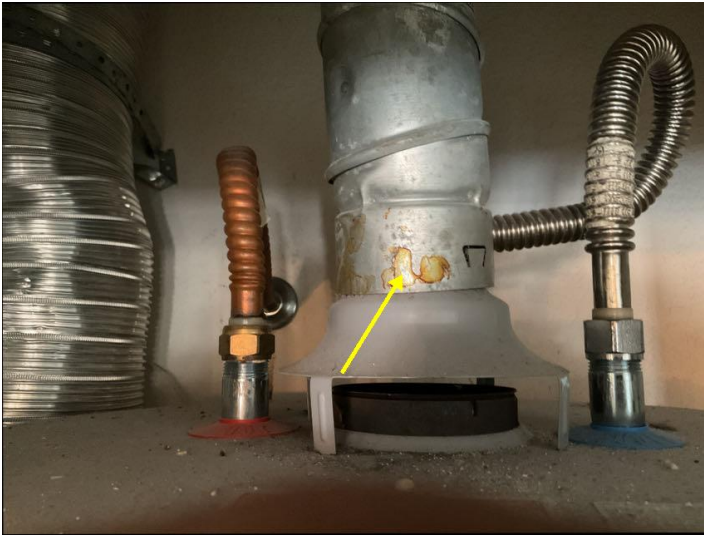
The water heater vent pipe is not screwed to the draft hood.

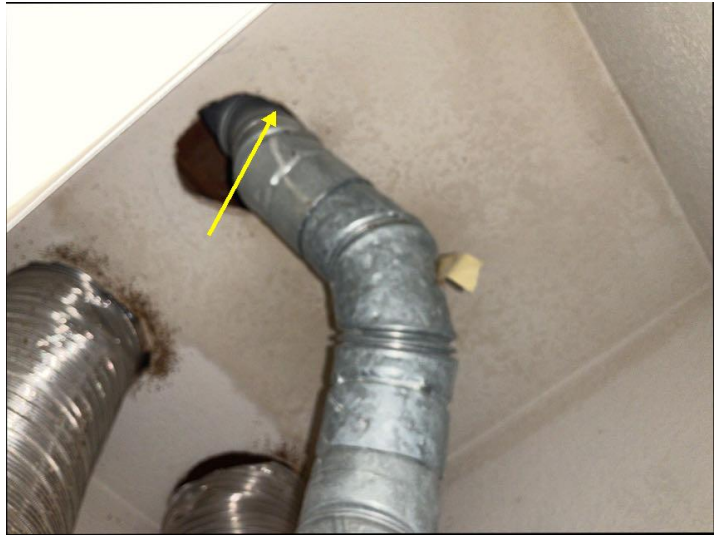
The gas was turned off at the time of the inspection the water heater and hot water lines could not be thoroughly inspected.

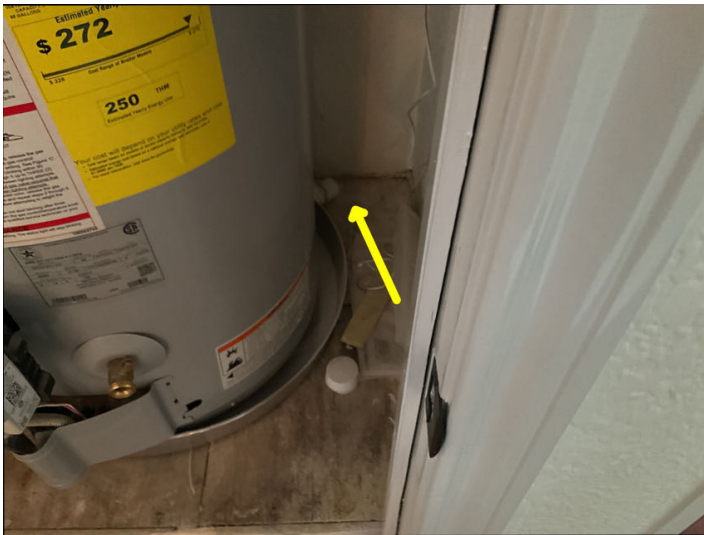
The water heater overflow pan is not connected to a drain line.

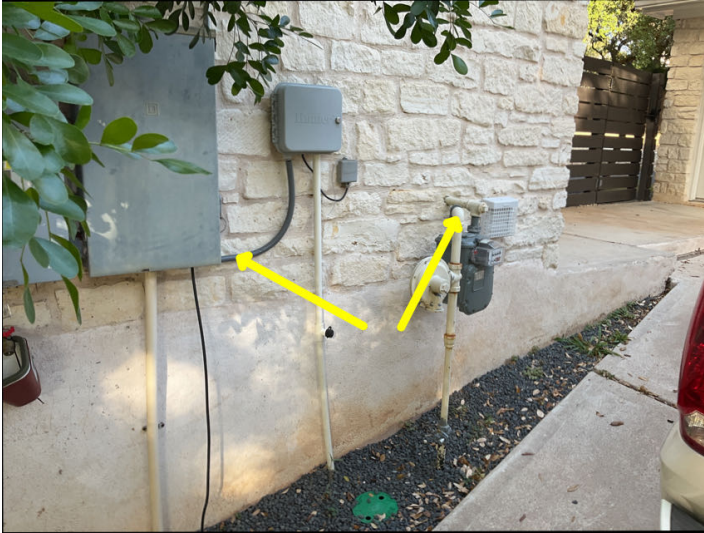
The gas lines are not bonded to the electrical system. Wasn't required when the house was built. The gas meter is located very close to the exterior electrical panel. Updating bonding should be relatively inexpensive.

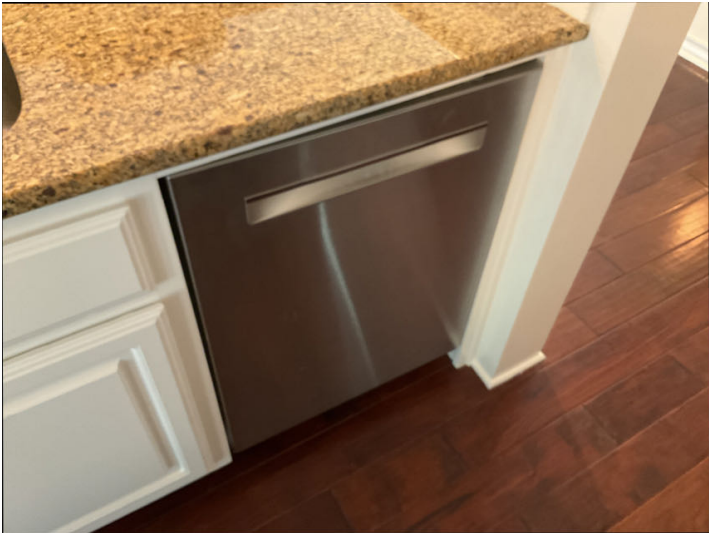
Dishwasher door springs are not functioning

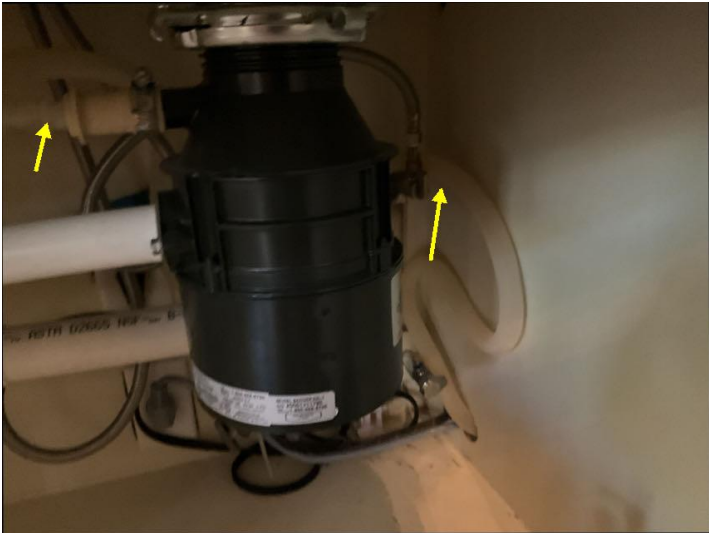
Back flow loop too low: The back flow prevention or anti siphon loop under the kitchen sink appears to be too low. Back flow protection helps to prevent gray water from the sink from running back into the dishwasher. Some modern dishwashers have built-in back flow prevention. If you are not sure if this unit has built-in back flow prevention you can install this by simply securing part of the discharge hose higher than the middle of the sink basin in the kitchen cabinet

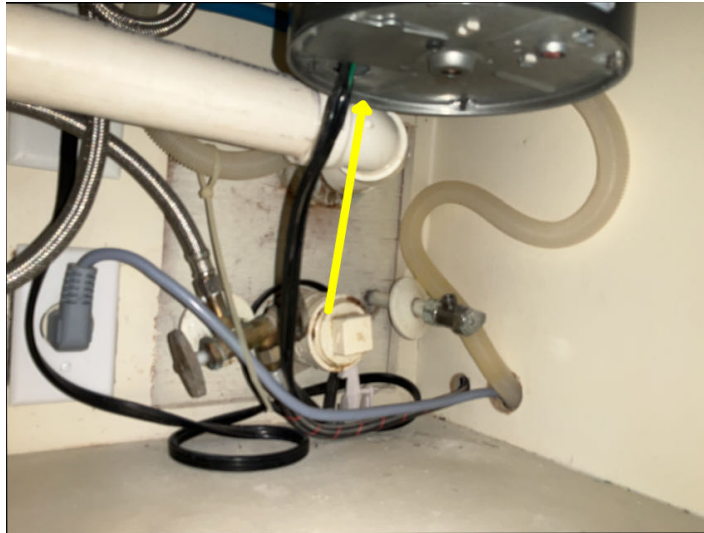
Electrical wire clamp on the bottom side of the disposal was not installed. This protects the electrical wires from being pulled out.

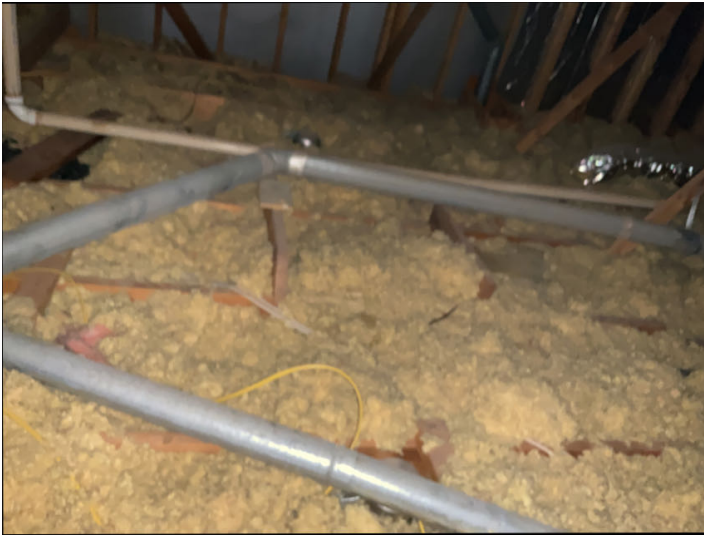
F.1. The bath fans are disconnected from the vent pipes and or the vent pipes are not present. Recommend updating to today's standards.

The bath fans are disconnected from the vent pipes and or the vent pipes are not present. Recommend updating to today's standards.

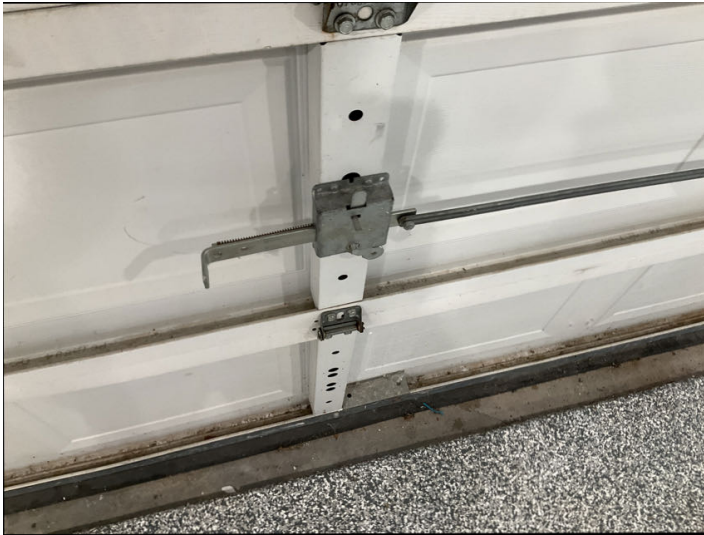
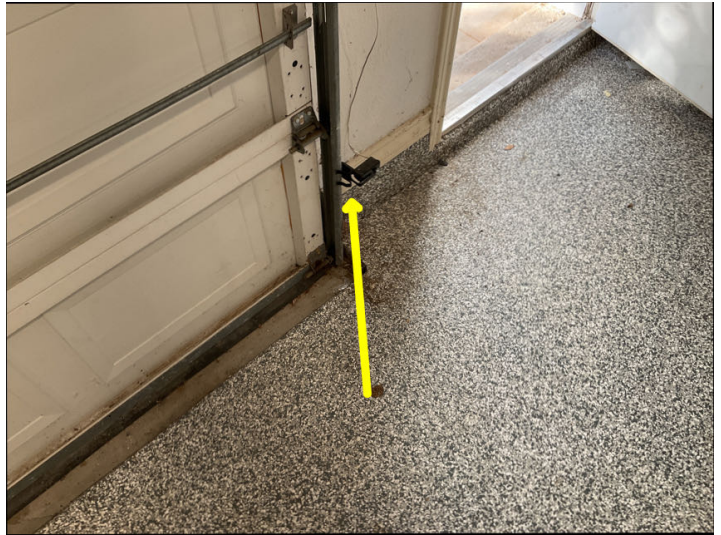
Note: It is recommended that the lock/latch on the garage doors be removed and or disabled when an automatic opener is in use.

Garage door sensors are raised to high. Garage door sensors should be installed between 4 inches and 6 inches off the floor surface.

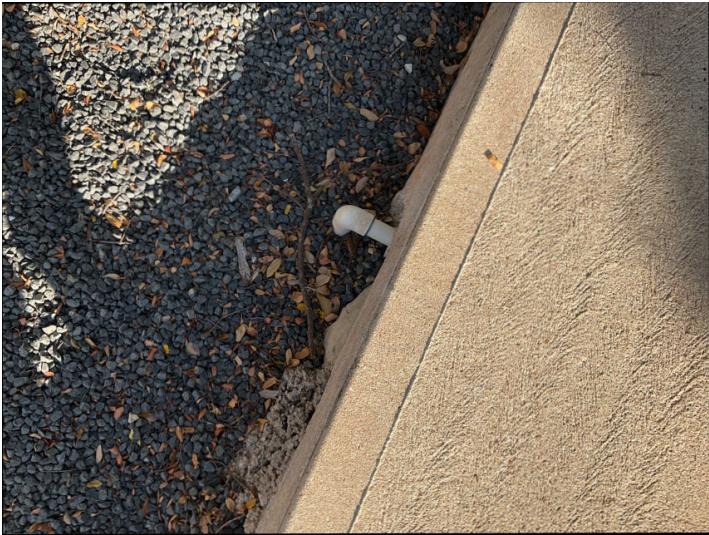
Exposed drip irrigation water lines observed in one or more locations.

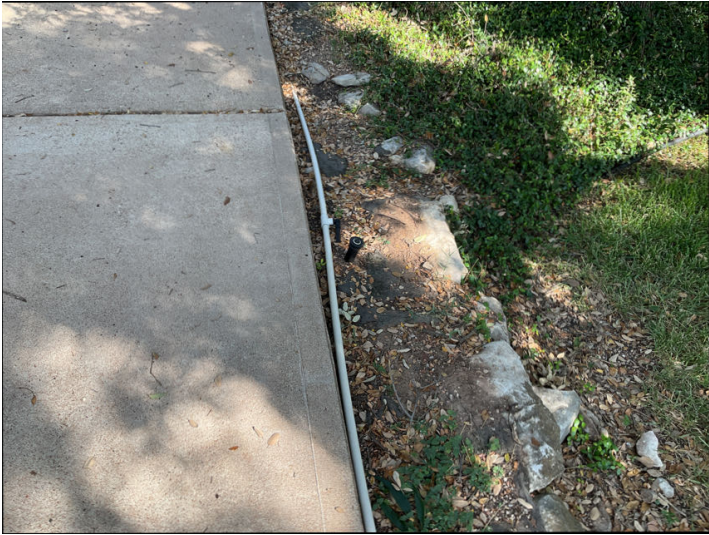
Exposed sprinkler lines observed on the right side of the driveway.

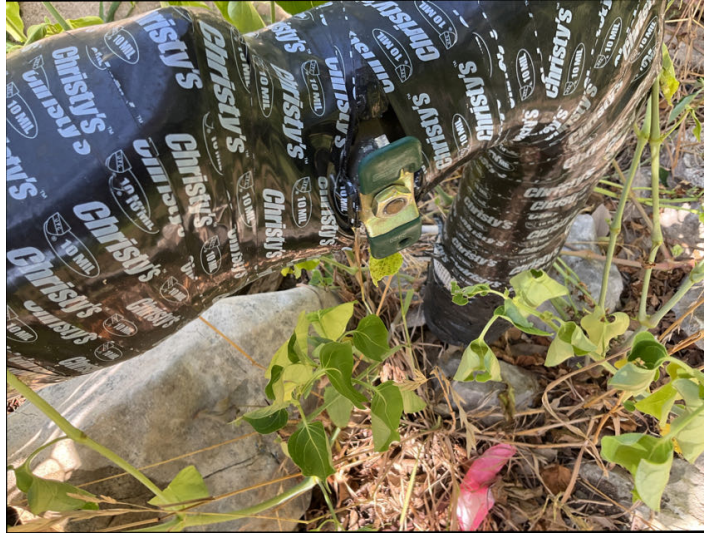
Low water pressure observed on sprinkler zones. Note sprinkler water double check valve was turned off at the time of the inspection. Turned on temporary to inspect sprinklers and then turn it back off.

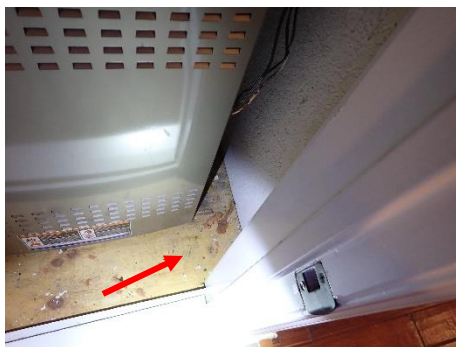
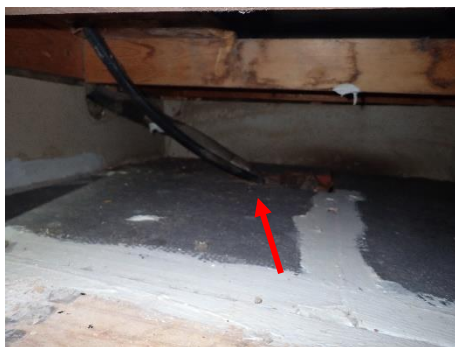
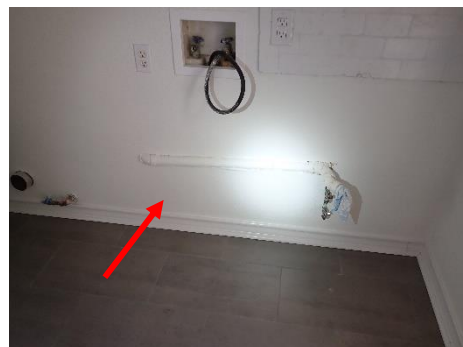
The lower HVAC unit was not working during the inspection. The return air plenum has evidence of water stains, the laundry room has a drain pipe that is half way out of the wall. This wall was tested.

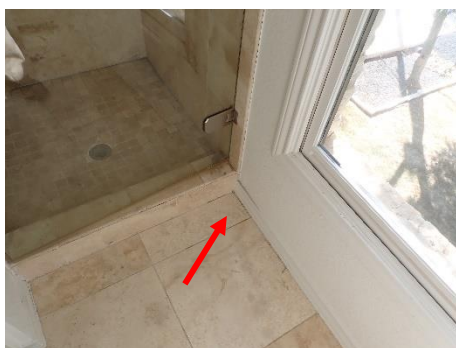
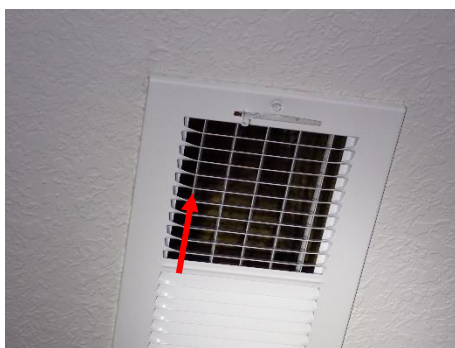
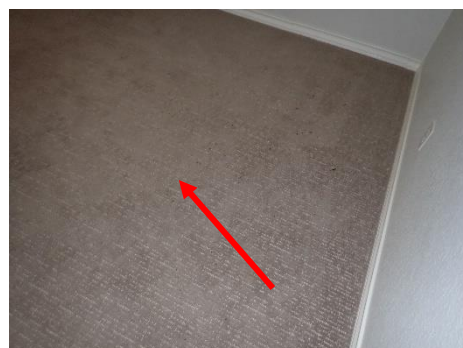
Damage to the sheetrock in the hall bathroom shower, there is visible mold in the register bucket of the middle bedroom and debris on the carpet that appears to have come from the air vent.

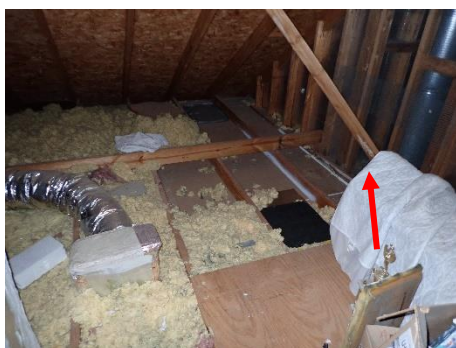
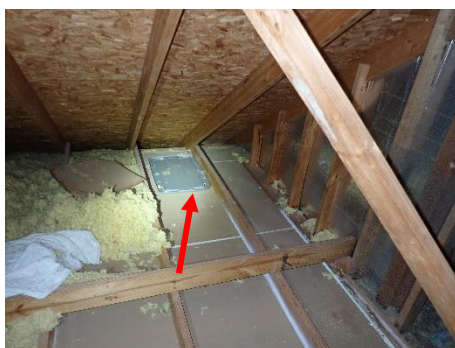
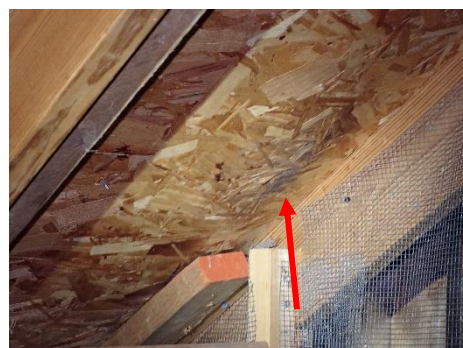
The insulation in the attic is removed from a possible repair to the left front bedroom. There is visible damage to the roof decking by the chimney.

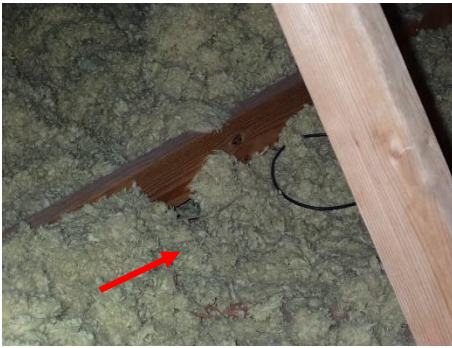
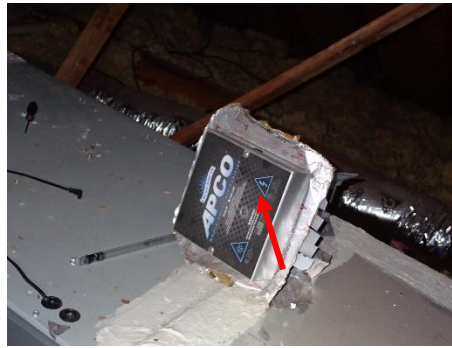
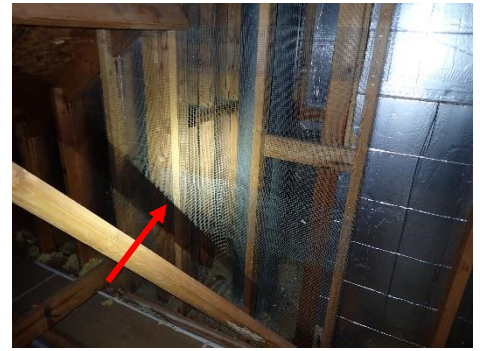
There is evidence of rodent activity in the attic insulation, an old UV light system not installed, and there is wire covering the chimney. This should be checked for code violations.
